BERRIGAN SHIRE COUNCIL

BERRIGAN PEDESTRIAN ACCESS AND MOBILITY PLAN

Des Gunn Landscape Design/Review Berrigan Shire Council

Adopted 16th July, 2014

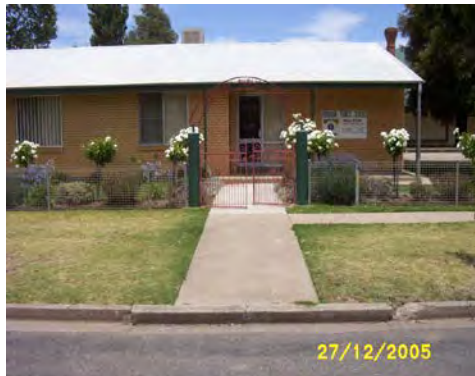
1

Path commences at school.

No ramp at school entry, Momalong St

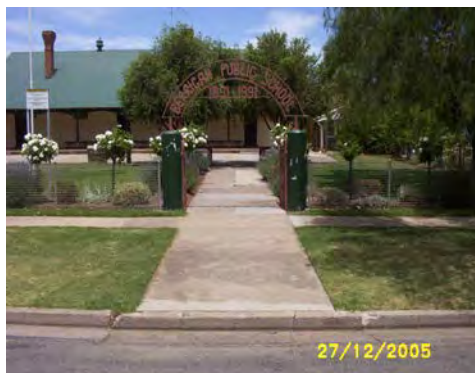
2

No ramp at second school entry.

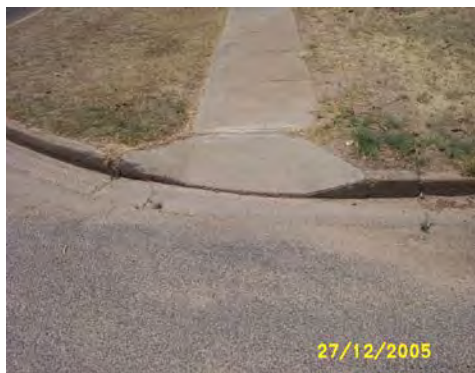
3

Baroga St east side at Momalong St.
Ramp does not line up with path. Lip
at channel is excessive.

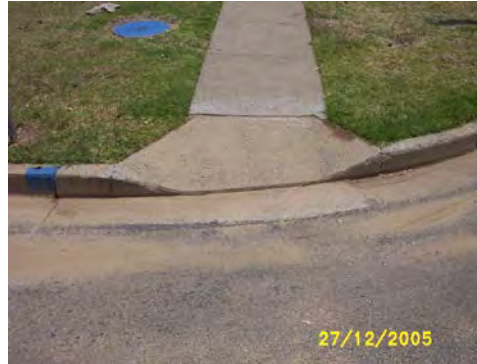
4

Barooga St west side at Momalong St.
Lip at channel is excessive.

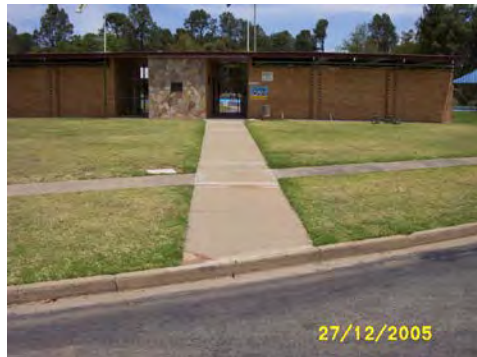
5

No ramp at path to pool.

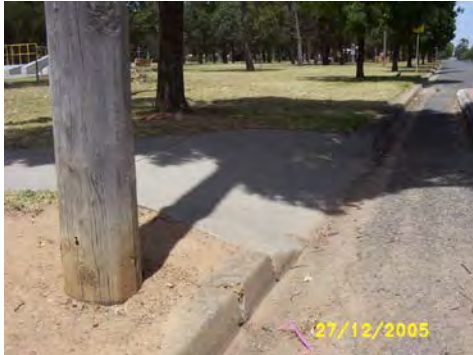
The ramp at Jerilderie St east side is steeper than the recommended 1:8 ramp grade.

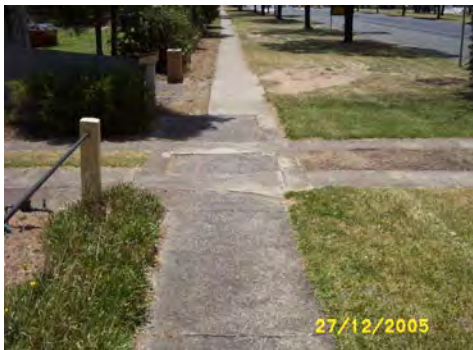
8

Path on west side of Jerilderie between Momalong St and Memorial Place. Alignment changes and rough concrete at driveway, No 129.

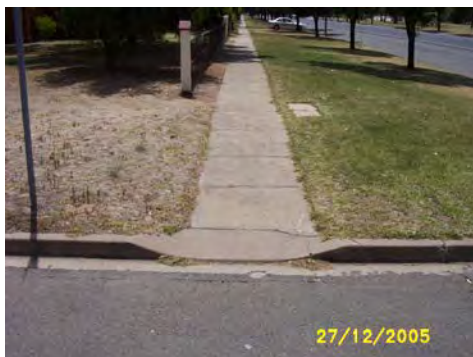
9

Kerb Ramp at Jerilderie St and Memorial place north corner. Lip at channel excessive.

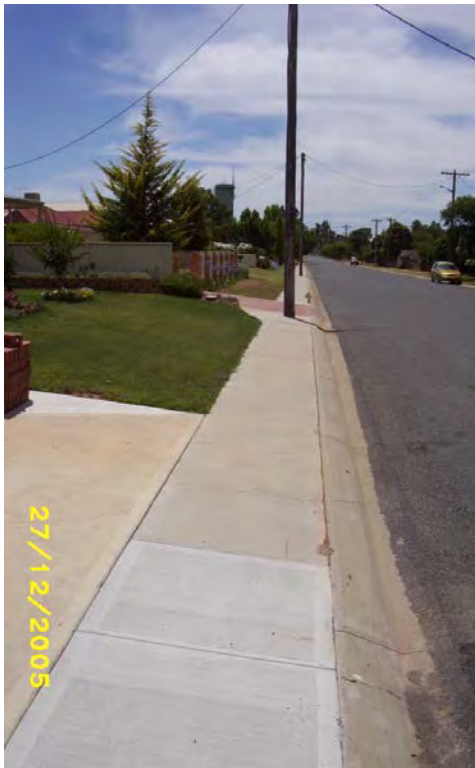
The side slope on this path down the west side of Davis St is excessive. Note also power poles in centre line of path.

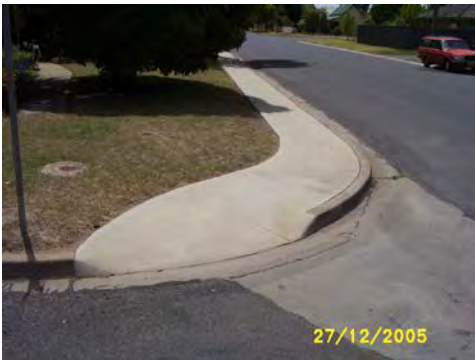
14

Back of kerb path line results in unusual kerb Ramps at Davis St and Momalong St. They seem to work well enough however.

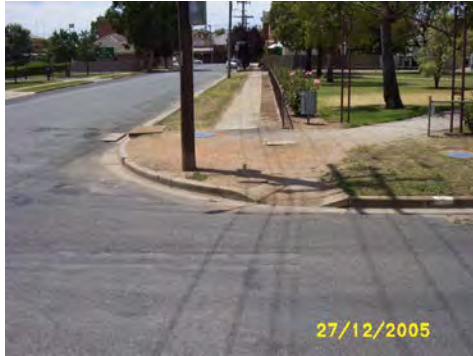
18

This whole corner at Cobram and Davis Sts needs a makeover, including pavement and kerb ramps.

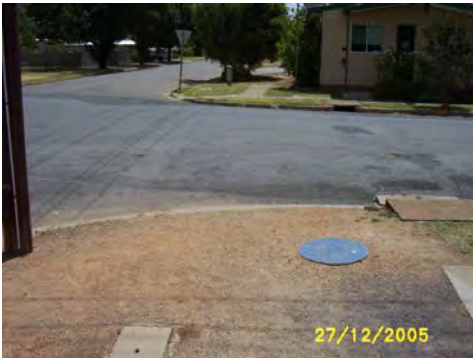
19

Kerb ramp needed, north west corner of Cobram and Budd Sts to link across to Apex Park.

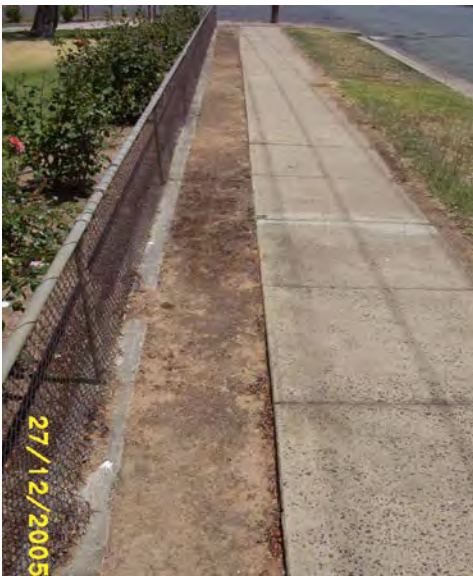
20

Consider paving this gap.

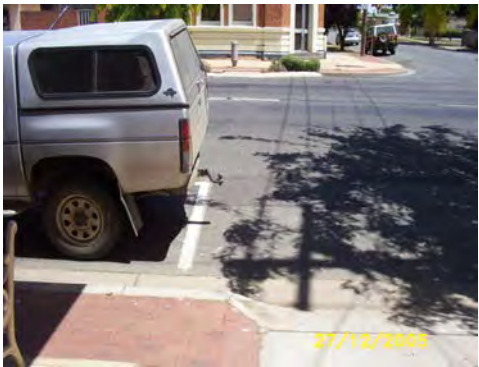
24

Above crossing viewed from other side.

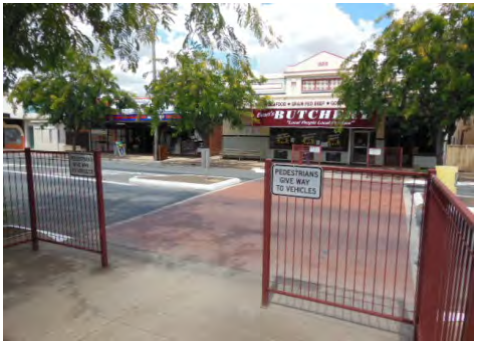
Informal pedestrian crossing on Chanter St. Seems to work OK, but use of different road pavement may send mixed signals about vehicle/pedestrian priority.

Signage installed

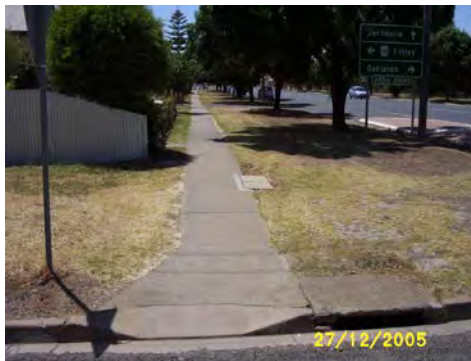
Kerb Ramp at Jerilderie and Momalong Sts, north west corner. Note lip.

Where kerb and path are not aligned, a wider ramp apron would be useful, allowing the path a wider profile adjacent to the ramp.

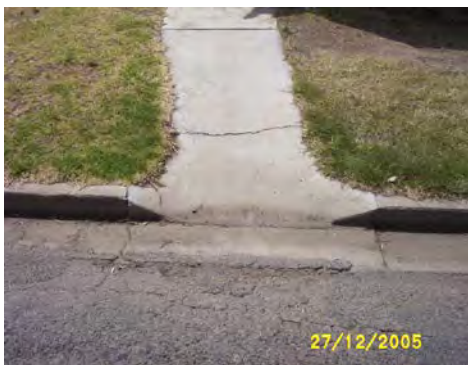
32

Ramp in Carter St to Belmont Buildings. Very steep section adjacent to channel. Path overgrown.

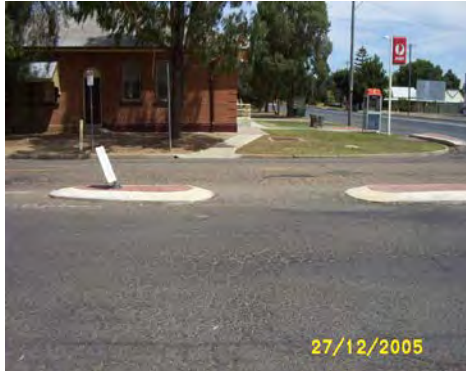
33

Pedestrian refuges in Carter St adjacent to Post Office are too narrow - min, 2.0 metres width preferred.

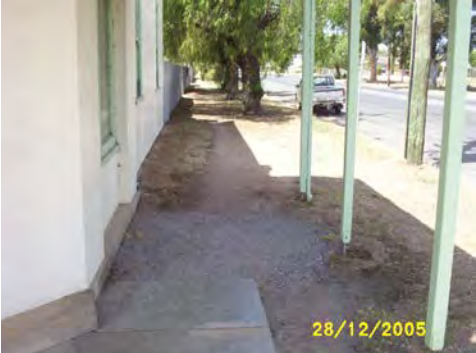
36	This path outside the Post Office should continue to Mamalong St.

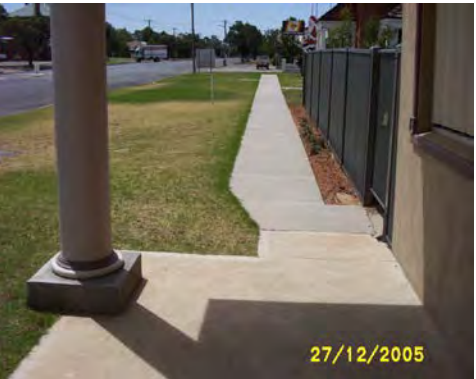
37	Evidence of worn tracks looking east along the north side of Carter St - is a path warranted?

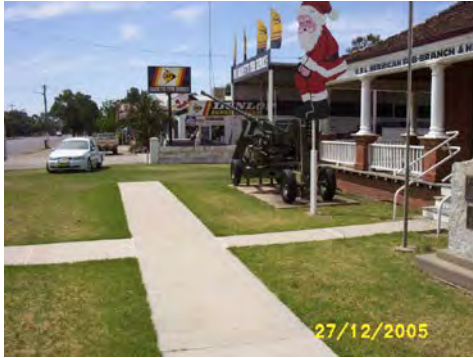
39

Path ends adjacent to RSL. Should continue at least to masonry wall visible in photo.

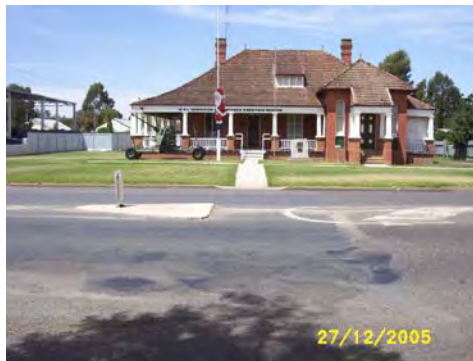
40

Consider upgrade of crossing at RSL.
Provide raised refuge island both sides of walkway. Consider hand rails.

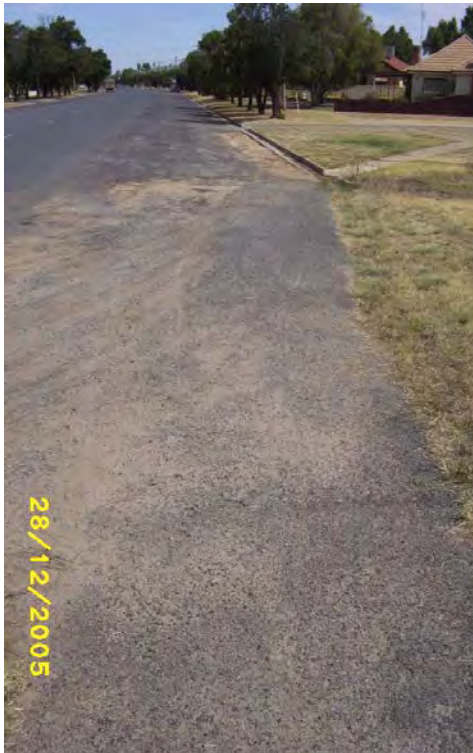
41

Existing sealed path, west side of Jerilderie St. This path continues from north of the rail line. Use of reflector posts on the outside of the path would help to distinguish the path from the adjacent and similarly coloured vehicle carriageway.

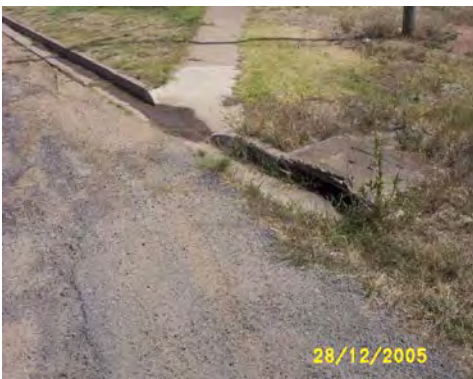
42

Junction of Asphalt and concrete paths, Jerilderie St near rail crossing. Maintenance upgrade recommended.

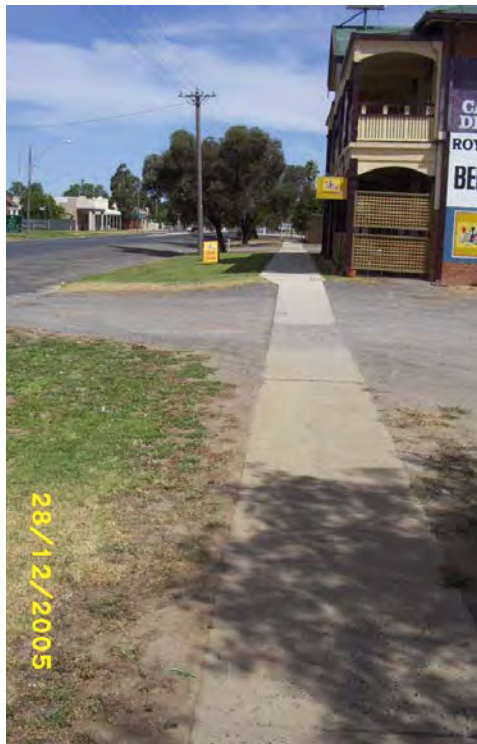
46

Jerilderie St east side looking south.
Reflector posts either side of Hotel
driveway would be useful.

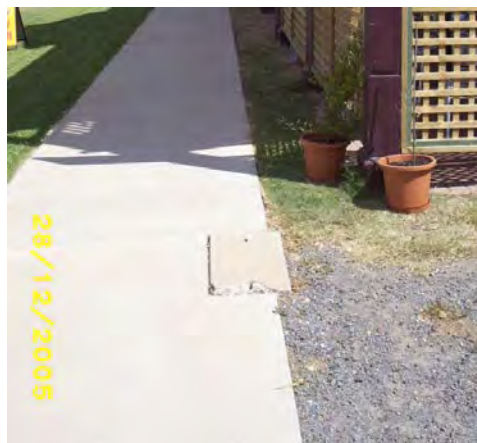
47

Telstra Pit Cover near Hotel is a trip
hazard.

Partially rectified

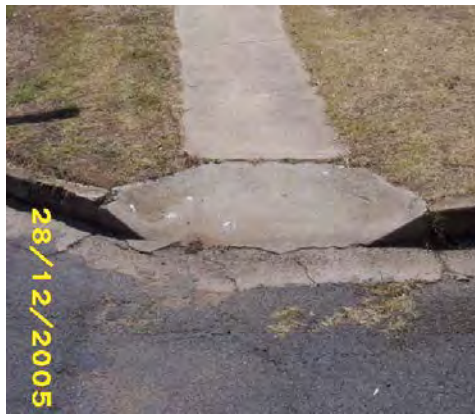
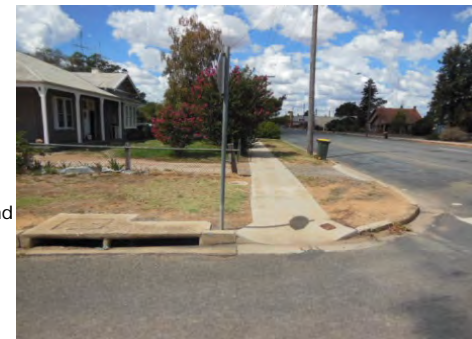
43

Both ramps at Chanter and Drummond
Sts have steep transitions and should
be replaced in due course.

Both ramps replaced

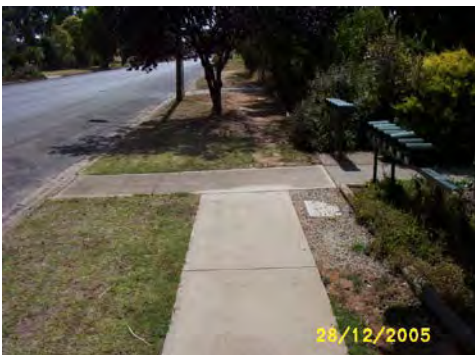
50

The path on Chanter St stops past
Drummond St - and the traffic
continues.

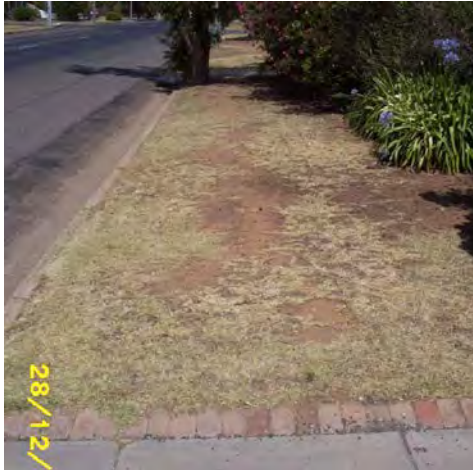
51

Evidence of wear on the south side of Chanter St, where a path may also be justified.

Path continued on South side to Drummond Street

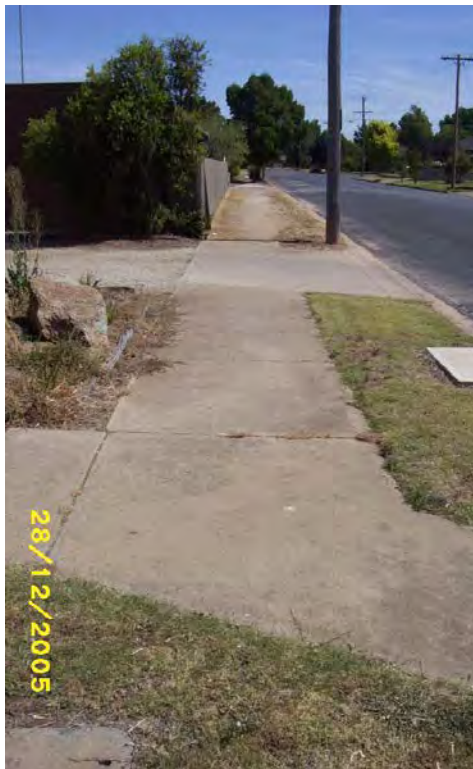
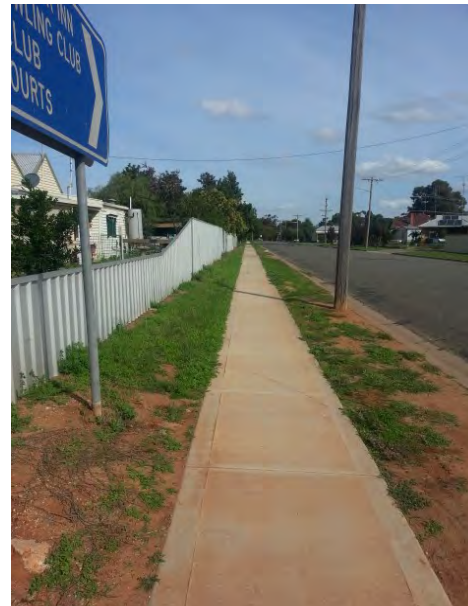
52

Pedestrian use is evident from the end of the existing short path in Mitchell St

Path constructed in Drummond Street to provide connection to Sports Club

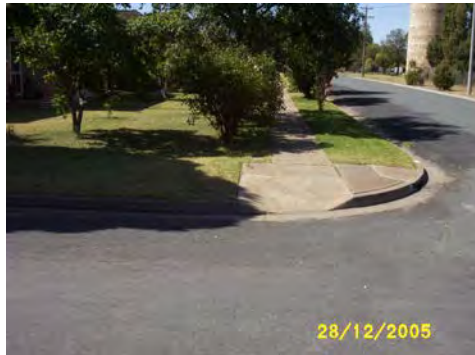
56

Ramp at Cobram and Stewart Sts,
north west corner.

Ramps replaced

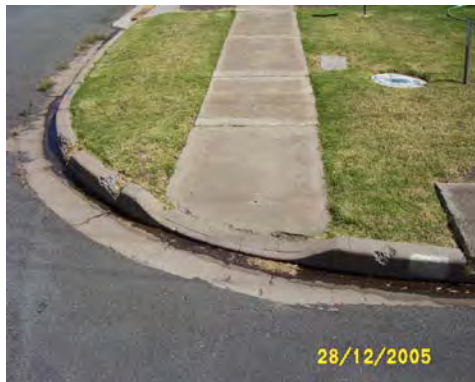
57

Ramp at Cobram and Stewart Sts,
south west corner.

Excessive lip, broken concrete around
ramp. Maintenance upgrade required.

Ramps replaced

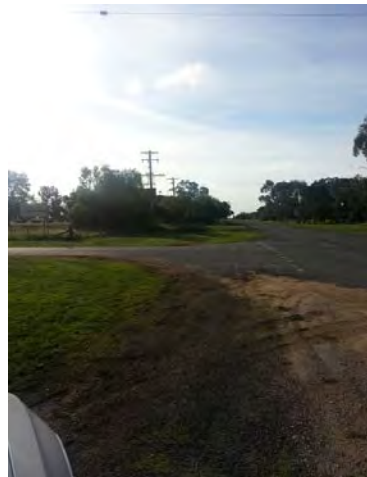
Sealed path should be continued to access to
sports ground

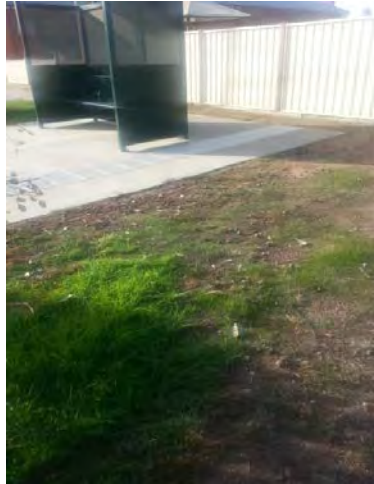
Tree near bus stop drops large gum nuts (slip hazard) should be removed

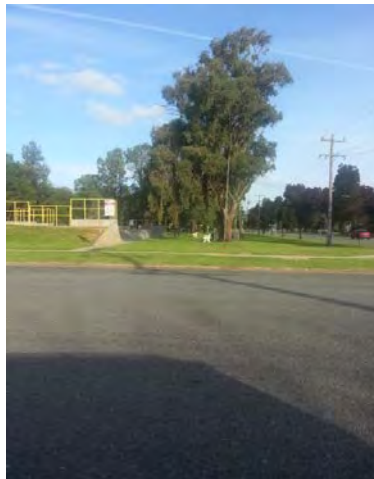
Ramp connection required at this point when path extended from Post Office

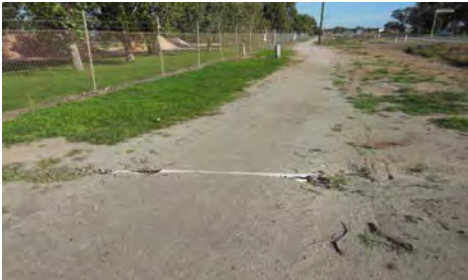
This Photo shows a badly broken drainage pipe beside the entry to McNaught's. It has sharp edges and no markers
A works request has also been forwarded to the overseer's for immediate attention

Risk Rating HIGH

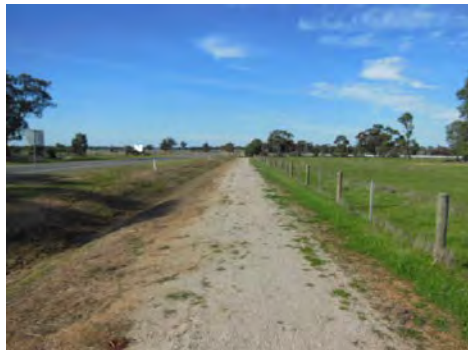
Outside Rural I.D.13915

This area is basically sound, however as displayed, is in need of weed control

Risk Rating LOW

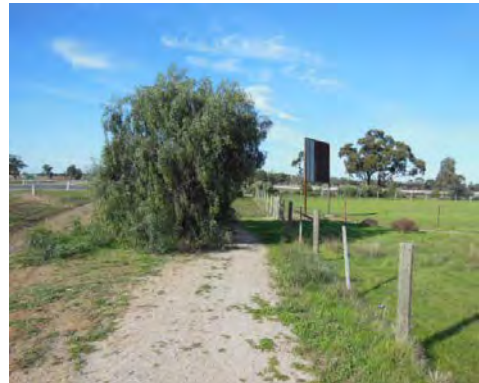
This area is approximately 50m's from Racecourse Rd.
As displayed, the tree has become somewhat of an obstruction and doesn't leave much space between itself and the fence.

Risk Rating MEDIUM

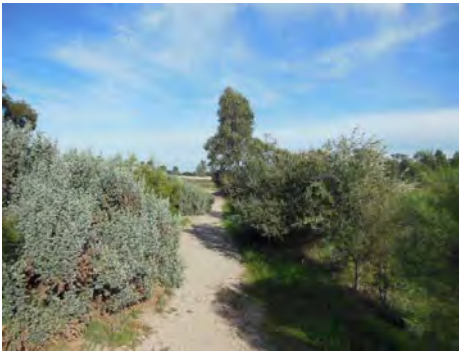
This is roughly 30m's from the path entry at Racecourse Rd.
Again the hazard is the close proximity of the plants to the path

Risk Rating

MEDIUM

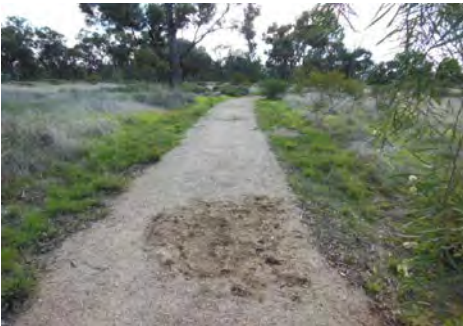
This area is known as the Tank Paddock where there are a number of hazards.
This displays what is probably the worst of several muddied area's throughout the length of the pathway

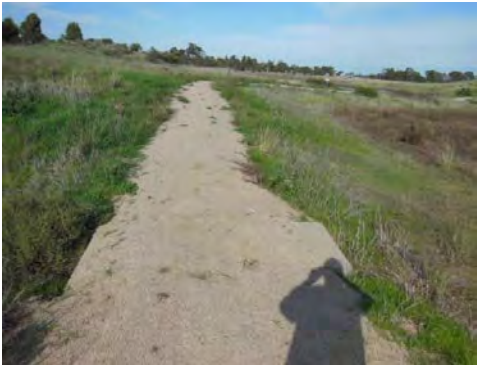
This culvert is approximately 40m's from the ponds and needs to be made identifiable with the use of guide posts

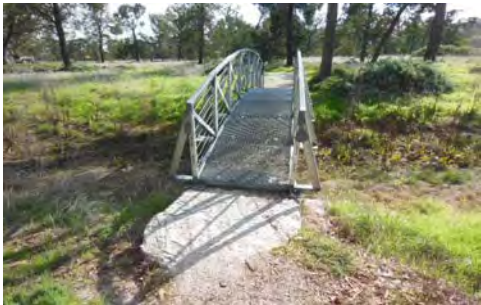
This bridge is roughly midway along the track and has trip hazards at both ends.
The bolts on the bridge floor are also hazardous

Risk Rating

MEDIUM TO HIGH

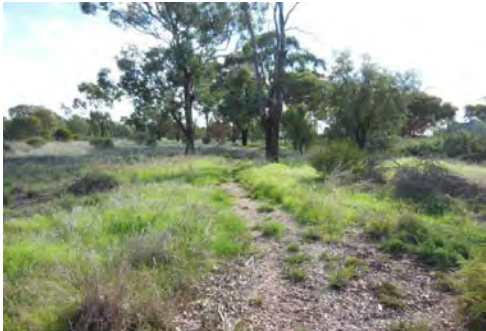
This area is known as the Police Paddock and is in poor condition throughout.
This photo was taken adjacent the depot of West Corugan where the path is very overgrown
