BERRIGAN SHIRE COUNCIL

FINLEY PEDESTRIAN ACCESS AND MOBILITY PLAN

Des Gunn Landscape Design/ Berrigan Shire Council

Adopted 16th July, 2014

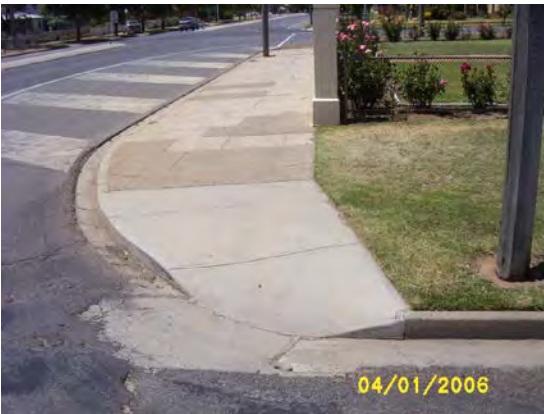
| Work ID | Routes | Photo ID | Key Inspection issues |
|---|--|---|---|
| F1 | | 1 | Ramp at Murray and Wollamai Sts, north east corner. The path should be returned around the corner a car length and a ramp constructed to specification. |

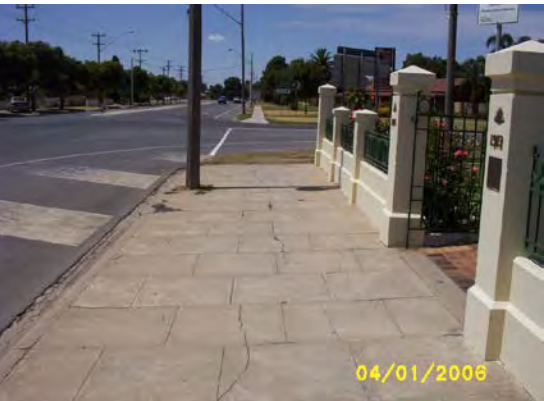
| Work ID | Routes | Photo ID | Key Inspection issues |
|---|--|---|---|
| F2 | | 2 | Path does not extend to kerb at Berrigan Road. |

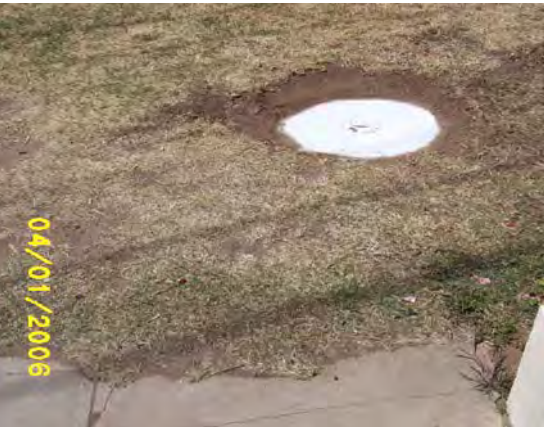
| Work ID | Routes | Photo ID | Key Inspection issues |
|---|--|---|---|
| | | 3 | Pit cover needs raising or adjacent levels lowering to remove trip hazard. |

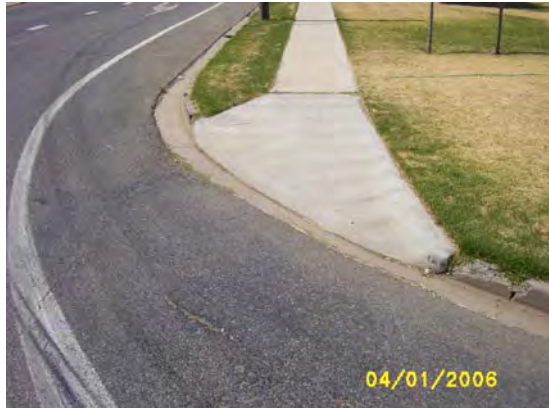
4

Ramp at Murray St and Berrigan Rd,
north east corner.
Ramps not right on large radius
corners are preferred.

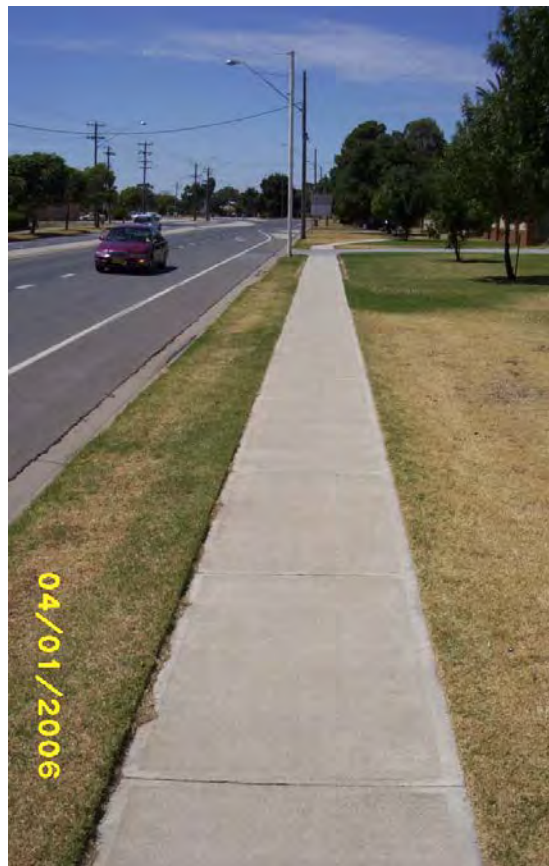
5

Some shade over this path would be
welcome.

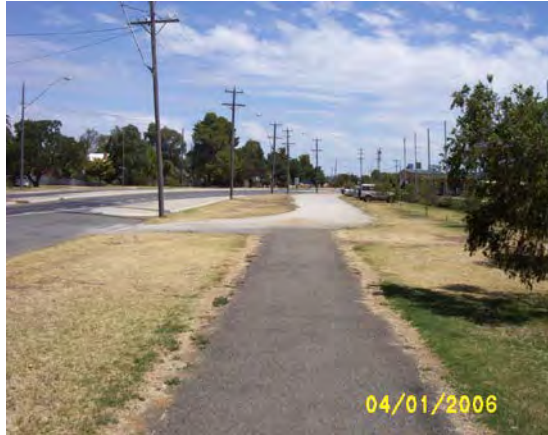
12

Looking south, west side of Murray St.

Lake path disappears into Bowling Club Car Park. No signs or reflector posts.

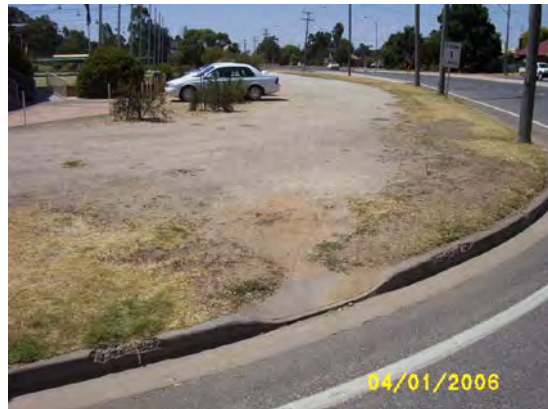
13

A proper path is warranted through the Bowls Club Car Park.

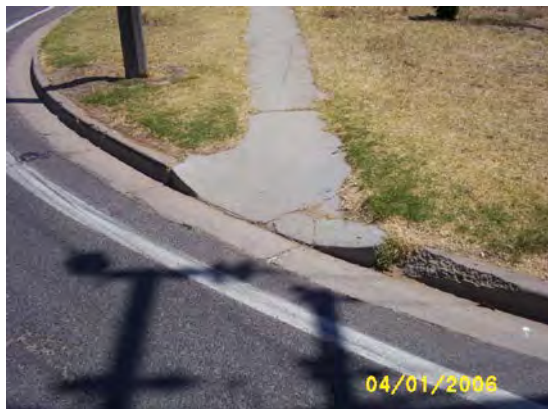
14

Opposite ramp to above at Murray and Tuppal Sts. Ramp out of specification - replace.

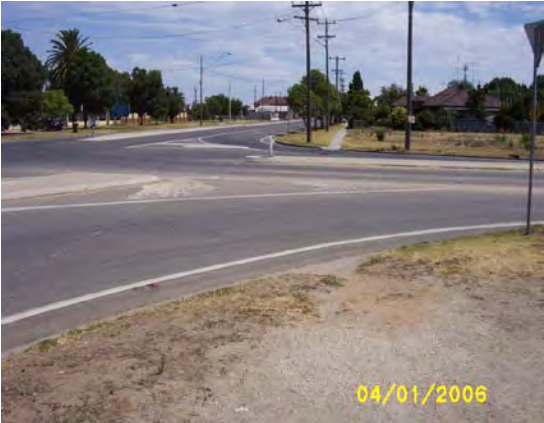
| Work ID | Routes | Photo ID | Key Inspection issues |
|---|---|---|---|
| | | | Better crossing facilities are warranted at the Riverina Highway. (Tuppal St) |

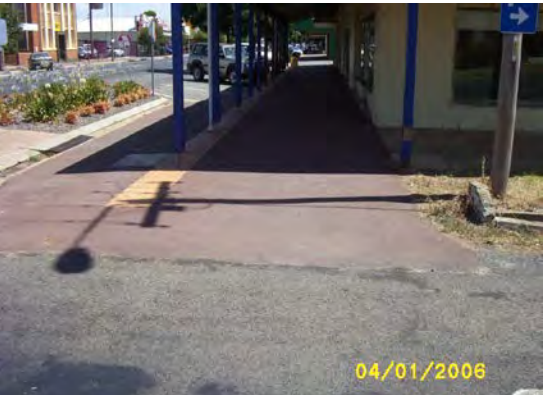
| Work ID | Routes | Photo ID | Key Inspection issues |
|---|---|---|---|
| | | | Murray and Wollamai Sts, south west corner. Transition from vehicle to pedestrian area unclear. Some additional line marking would address this issue. |

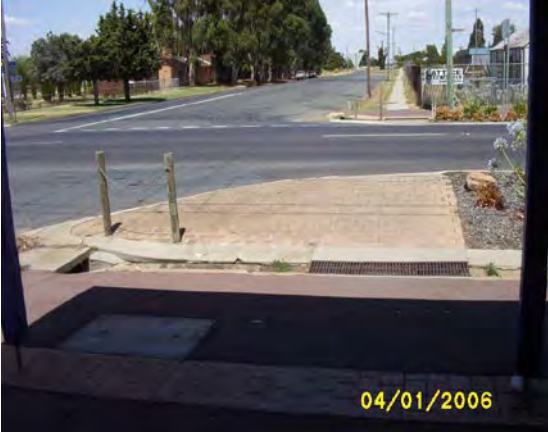
| Work ID | Routes | Photo ID | Key Inspection issues | |
|---|---|---|---|---|
| | | 18 | <p>This crossing at Woolamai and Murray Sts is looking due for an upgrade.</p> | <p>04/01/2006</p> <p>Revamped</p> |

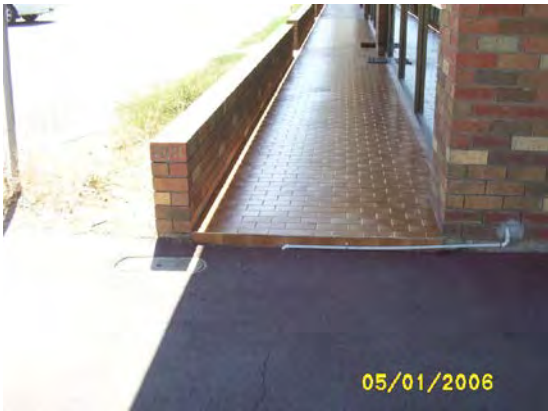
| Work ID | Routes | Photo ID | Key Inspection issues | |
|---|---|---|---|---|
| | | 19 | <p>Small changes of level such as this at the Real Estate office in Murray St are a potential hazard.</p> <p>Streetscaped</p> | <p>05/01/2006</p> |

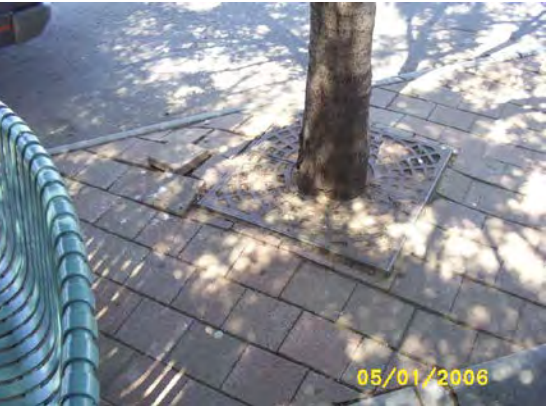
| Work ID | Routes | Photo ID | Key Inspection issues | |
|---|---|---|---|---|
| | | 20 | <p>Some damage to paving in Murray St from tree roots is evident.</p> <p>Streetscaped</p> | <p>05/01/2006</p> |

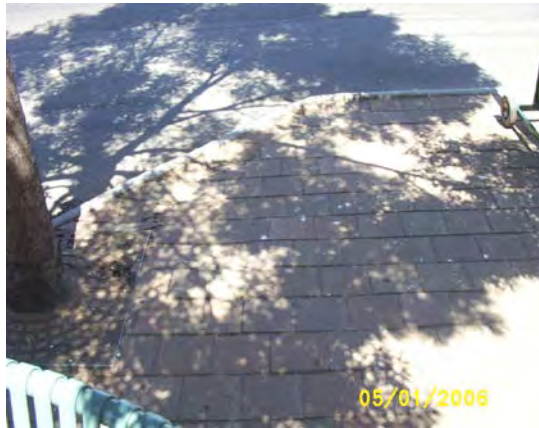
A trip hazard is created where paving levels have dropped at back of kerb.

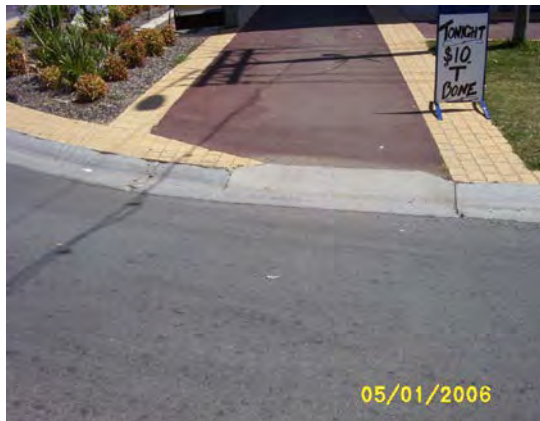
Slightly different detailing would give a safer edge by returning the band of lighter paving right across the path.

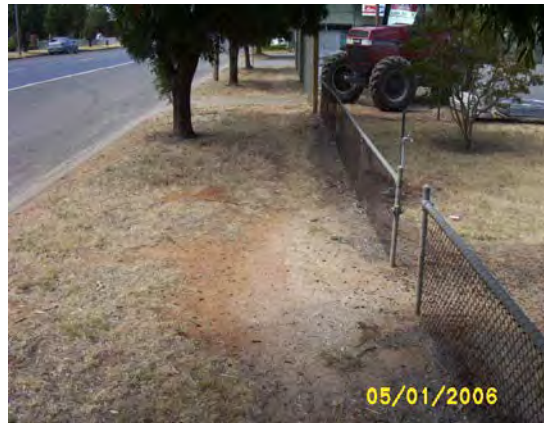
28

Evidence of pedestrian wear at entrance to Band Hall.

A path on the east side of Murray St between Osborne St and Headford St would balance the main St network.

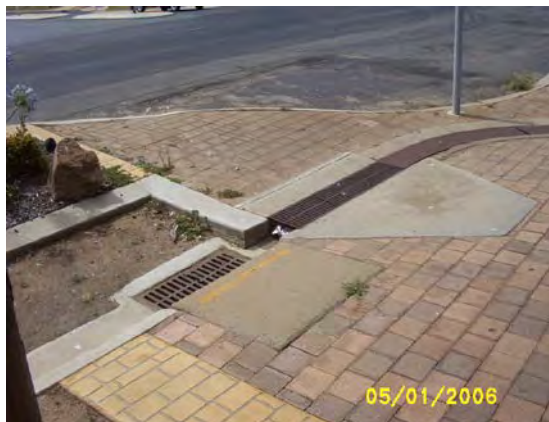
32

Detail view, Warmatta and Murray Sts, south east corner.
This somewhat messy arrangement will be rectified with reconstruction of Warmatta St closure.

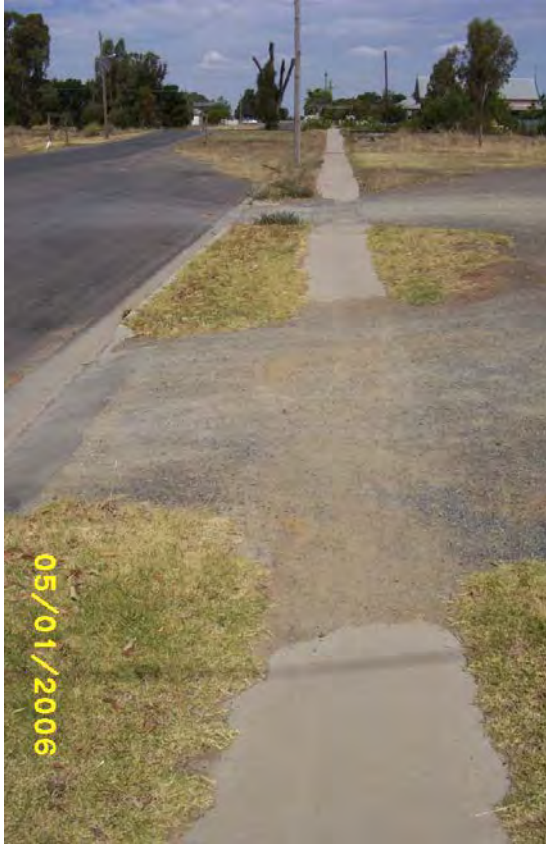
39 The path is seriously compromised at vehicle crossings.

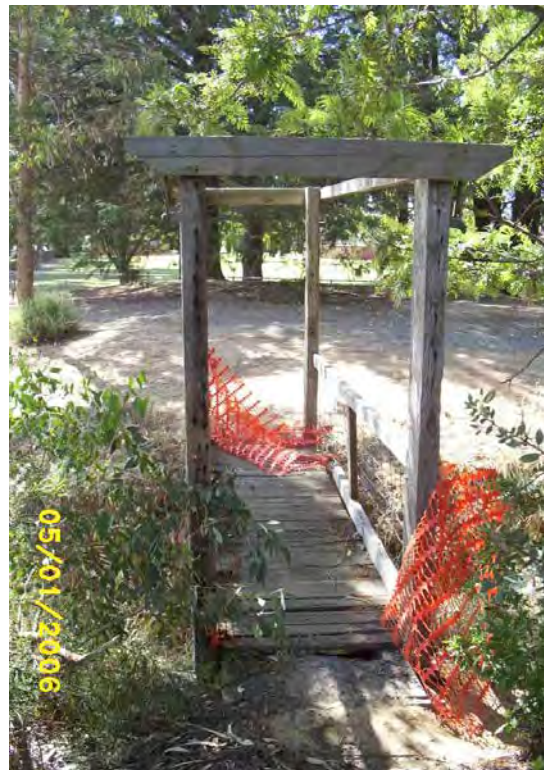
42

Bridge on Wollamai still being used!

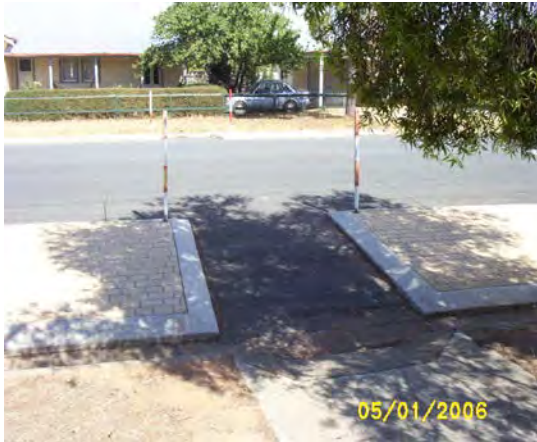
46

Part of blister crossing near church, but no path other side.

Consider intallation of a kerb ramp east side of Denison, and constriction of a short path link back to Tuppal St.

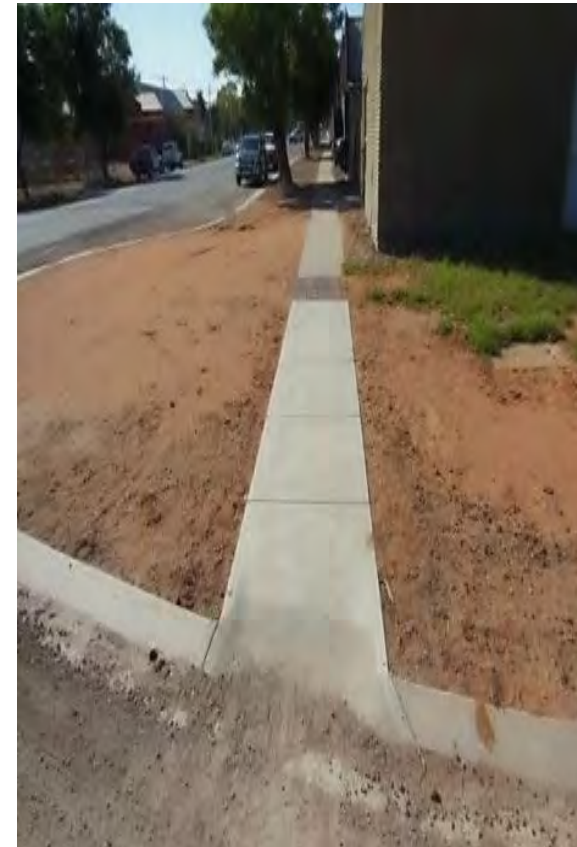
52

Denison St looking south to Warmatta St.
This path does not continue to include a kerb ramp at Warmatta St

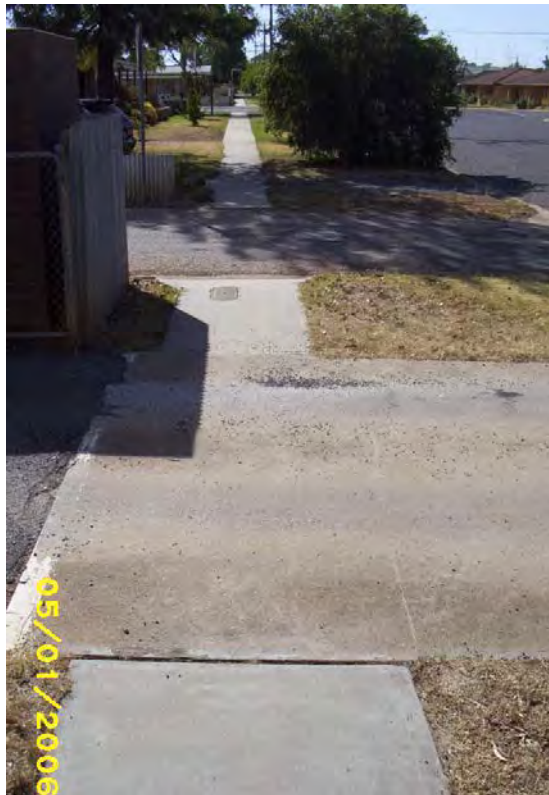
64

The footpath 'disappears' at the laneway crossing creating potential ambiguity about whether cars or pedestrians have priority. Consider reflector posts each side.

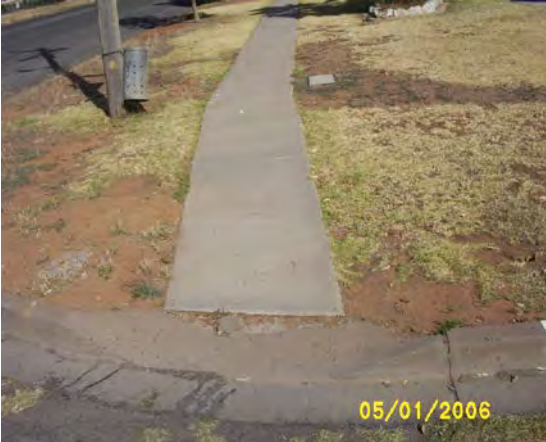
| Work ID | Routes | Photo ID | Key Inspection issues | |
|---|---|---|--|---|
| F19 | | 69 | <p>South east corner, Warmatta and Tocumwal Sts. The kerb ramp is broken at the interface with the new concrete, and with a steep final grade. Construct new ramp in association with path and ramp works recommended for link north to school.(See below)</p> | |

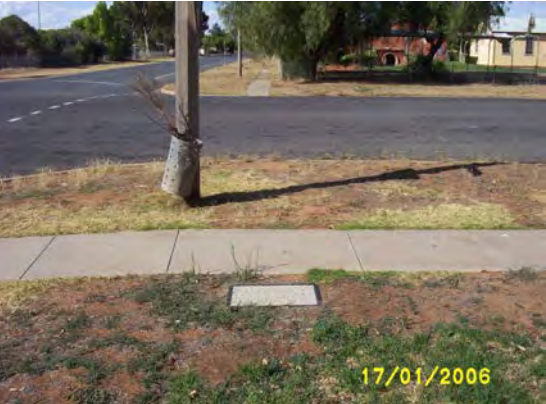
| Work ID | Routes | Photo ID | Key Inspection issues | |
|---|---|---|--|---|
| F18 | | 70 | <p>A path link and ramp is required at this south east corner of Warmatta and Tocumwal Sts.</p> | |

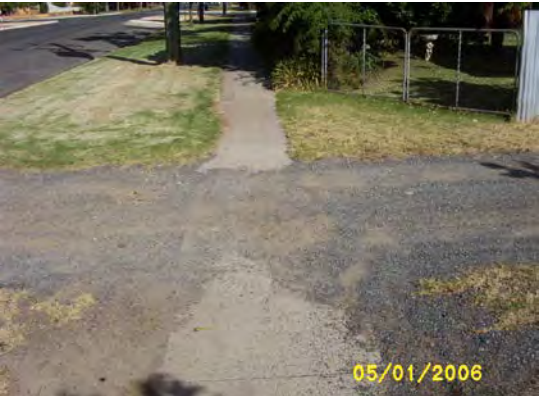
| Work ID | Routes | Photo ID | Key Inspection issues | |
|---|---|---|--|---|
| | | 71 | <p>Gravel across lane way compromises path, south side of Warmatta St between Tocumwal and Coree Sts.</p> | |

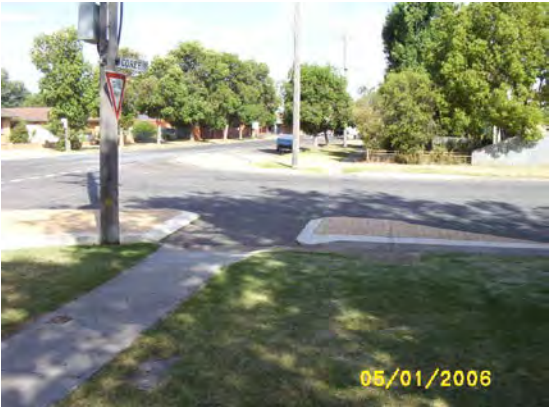
| Work ID | Routes | Photo ID | Key Inspection issues |
|---|---|---|--|
| | | | Corner treatment, south west corner, Warmatta and Coree Sts. Grind Lip of ramp. |

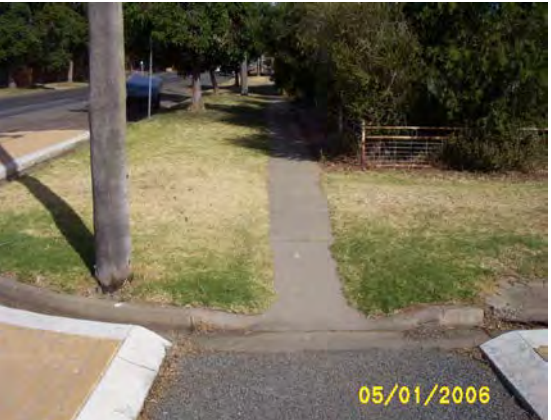
| Work ID | Routes | Photo ID | Key Inspection issues |
|---|---|---|--|
| | | | Corner treatment, south east corner, Warmatta and Coree Sts. Grind Lip of ramp. |

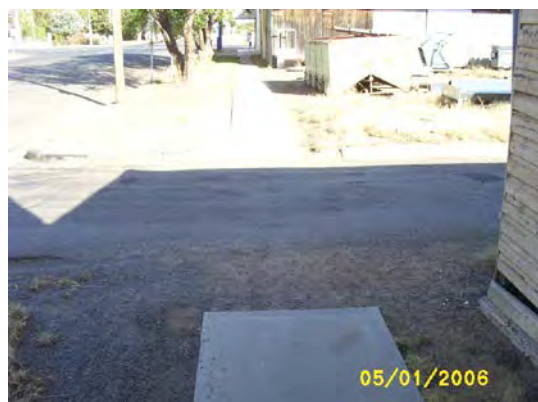
85

Path stops at service road adjacent to foundry. Signs and/or reflector posts should be considered here.

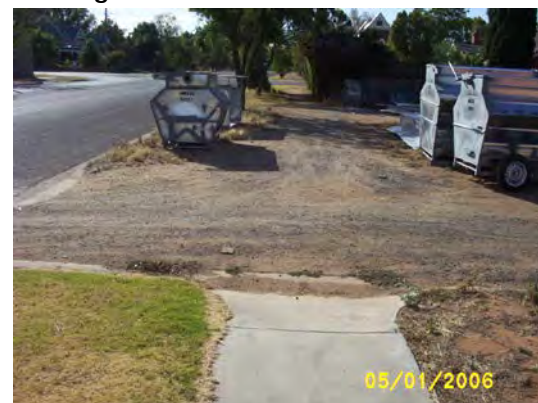
What chance a footpath here?
A footpath link is desirable in this section of Wollamai St, but foundry operations need to be adjusted to maximise pedestrian safety and maintenance efficiency.

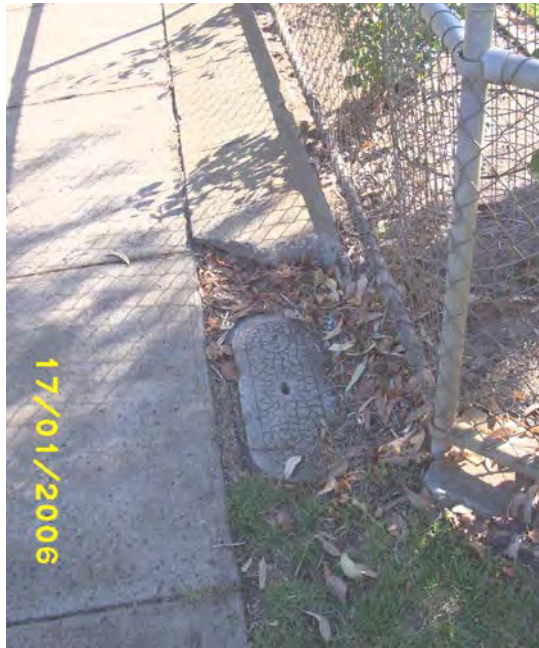
91

Broken infill concrete adjacent to
Telstra Pit outside the school may be a
hazard for pedestrians.

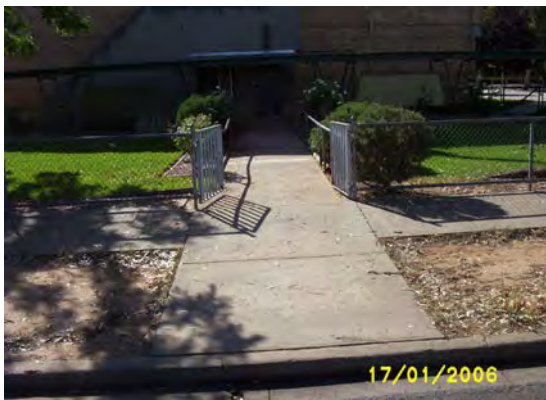
92

No kerb ramp at school access.

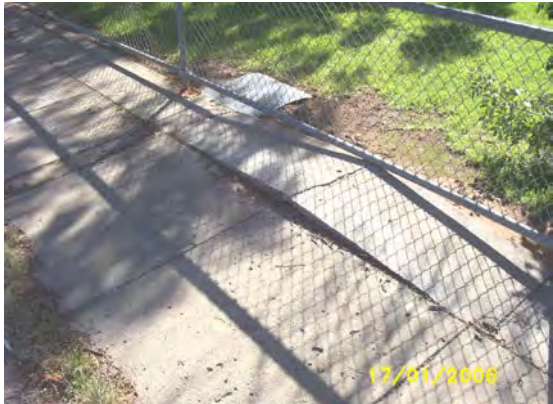
93

Lifted section of infill concrete may be trip hazard.

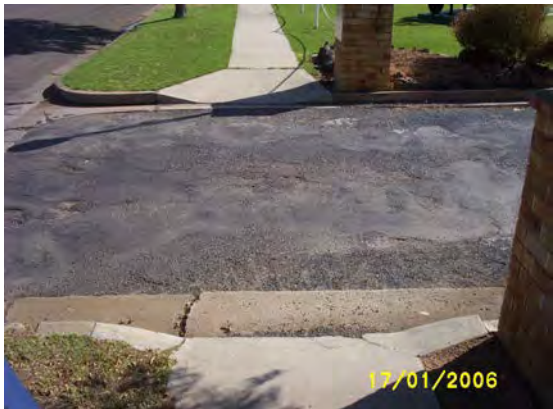
94

Ramps at northern car park access, RSL Club. Northernmost ramp is uncomfortably steep, a little broken, and has a rough lip.

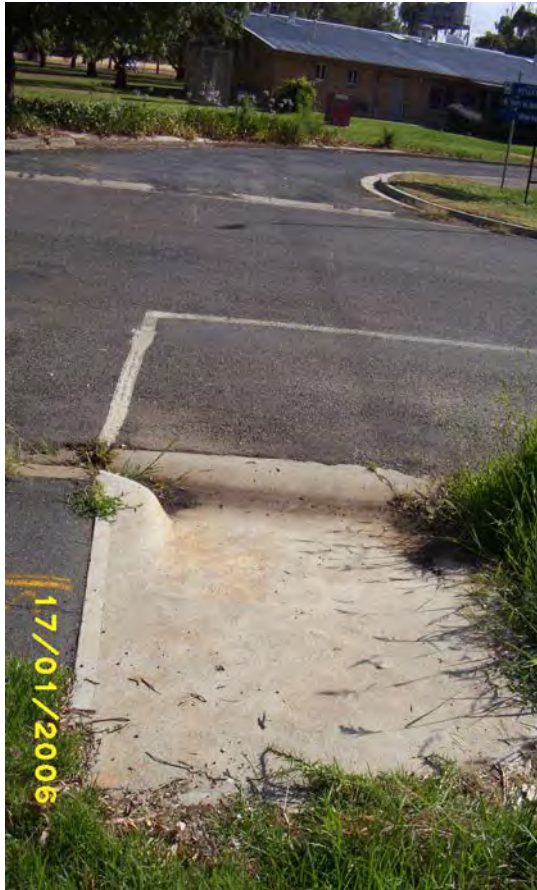
98

Crossing point is oriented directly at vehicle access to Hospital. Relocate crossing. Provide full blister crossing.
