BERRIGAN SHIRE COUNCIL

FINLEY PEDESTRIAN ACCESS AND MOBILITY PLAN

Des Gunn Landscape Design/ Berrigan Shire Council

Adopted 16th July, 2014

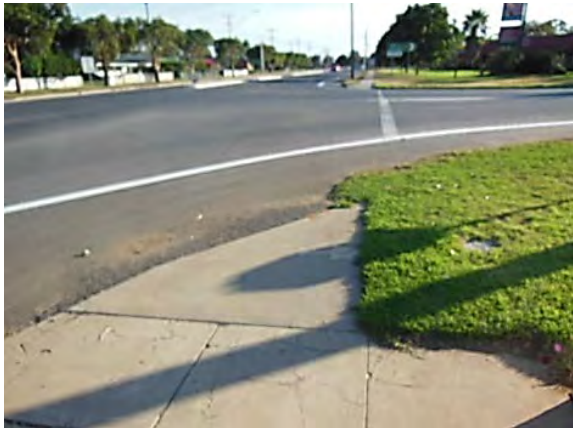
| Work ID | Routes | Photo ID | Key Inspection issues |
|---|--|---|---|
| | | 3 | Pit cover needs raising or adjacent levels lowering to remove trip hazard. |

| Work ID | Routes | Photo ID | Key Inspection issues |
|---|--|---|---|
| | | | Path extended |

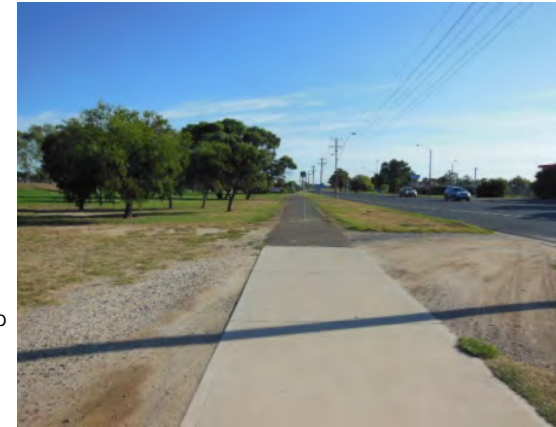
F7

Looking south, west side of Murray St.

Lake path disappears into Bowling Club Car Park. No signs or reflector posts.

Path installed

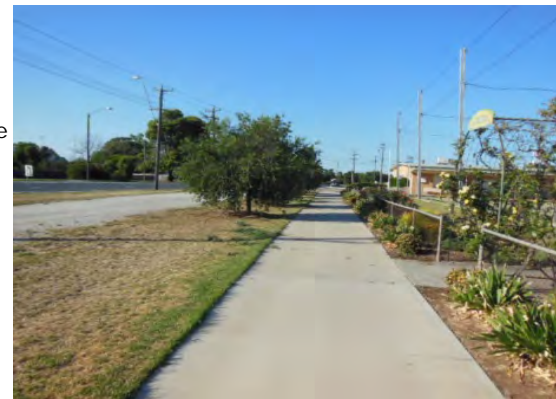
F8

A proper path is warranted through the Bowls Club Car Park.

Note existing ramp is steep with excessive lip.

Path installed

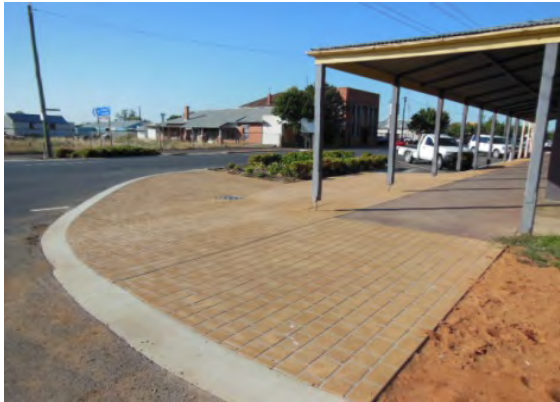
| Work ID | Routes | Photo ID | Key Inspection issues |
|---|---|---|---|
| | | 17 | |

| Work ID | Routes | Photo ID | Key Inspection issues |
|---|---|---|---|
| | | | Ramp at Wollamai and Murray Sts, north west corner. Maintenance repairs needed. |

| Work ID | Routes | Photo ID | Key Inspection issues |
|---|---|---|---|
| | | | Revamped |

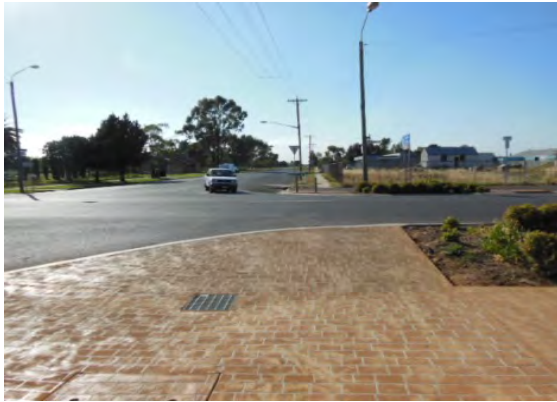
| Work ID | Routes | Photo ID | Key Inspection issues | |
|---|---|---|---|---|
| | | 18 | <p>This crossing at Woolamai and Murray Sts is looking due for an upgrade.</p> | <p>04/01/2006</p> <p>Revamped</p> |

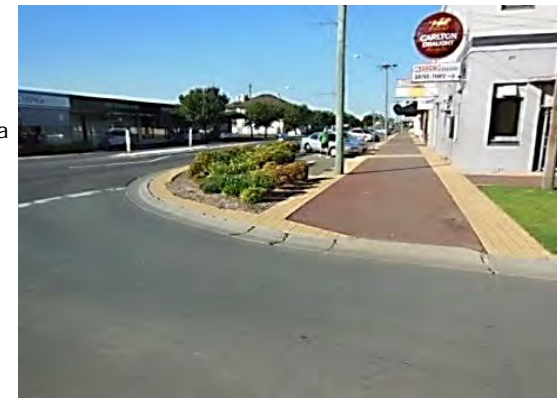
23

Slightly different detailing would give a safer edge by returning the band of lighter paving right across the path.

Reported 05/2013 footpath inspections

Worse now

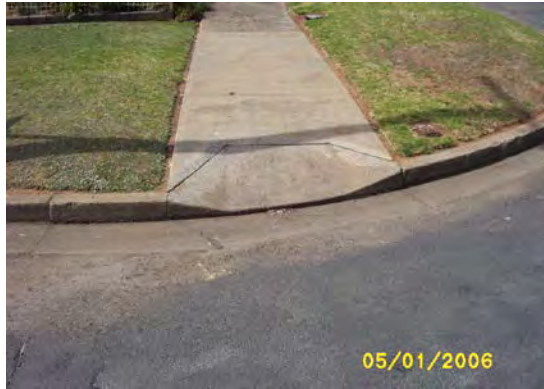
27

Osborne and Murray Sts north west corner, where path effectively ends. Lip at hannel invert is excessive

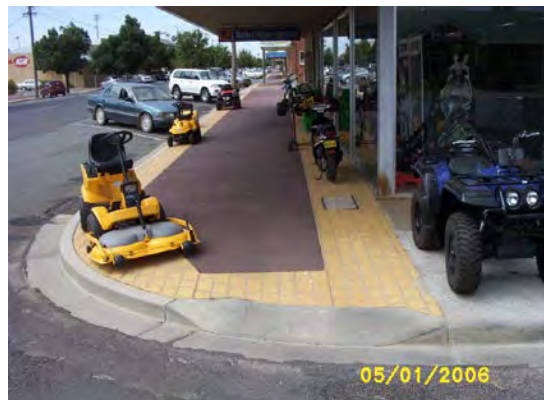
29

A path on the east side of Murray St between Osborne St and Headford St would balance the main St network.

Headford and Murray Sts, north east corner.

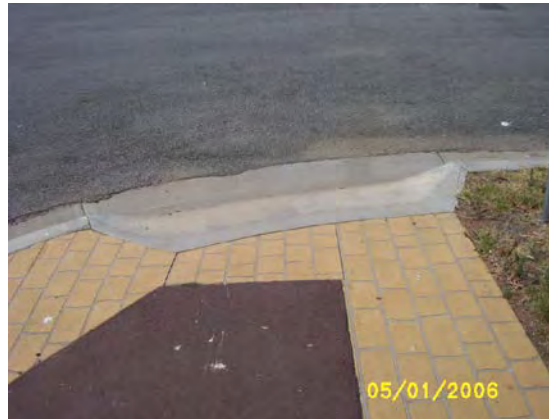
30

Burton and Murray Sts, south east corner.

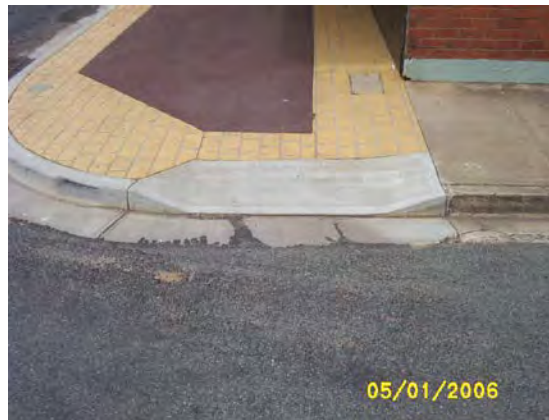
31

Burton and Murray Sts, north east corner.

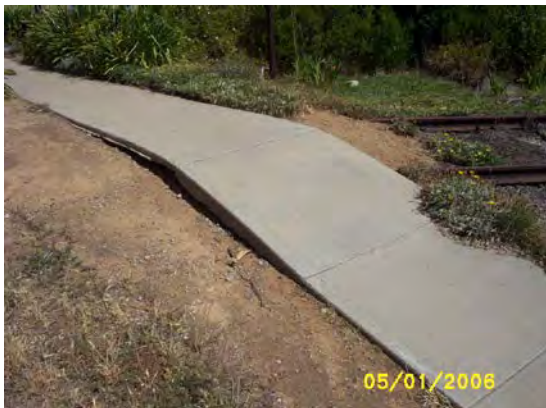
40

Edge of path exposed where path crosses rail line - fill to match path surface levels.

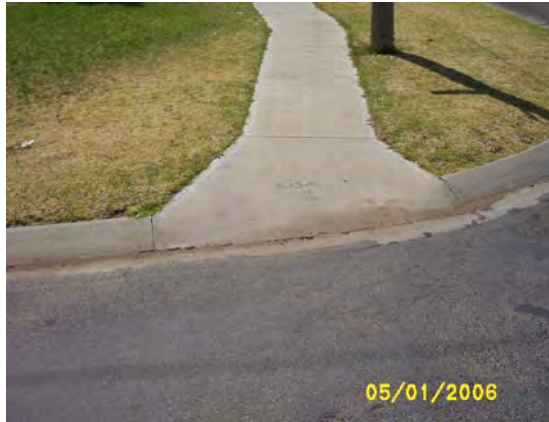
41

Ramp at Finley and Wollamai Sts,
where path ends.

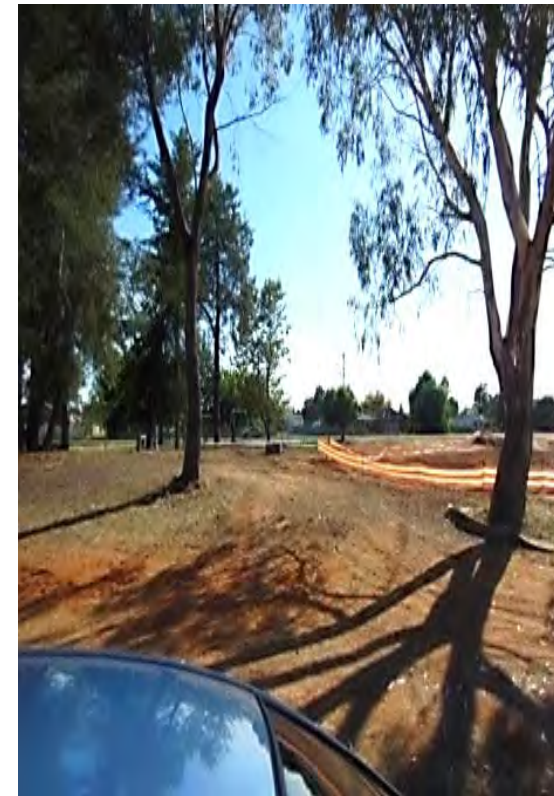
42

Bridge on Wollamai still being used!

Bridge removed

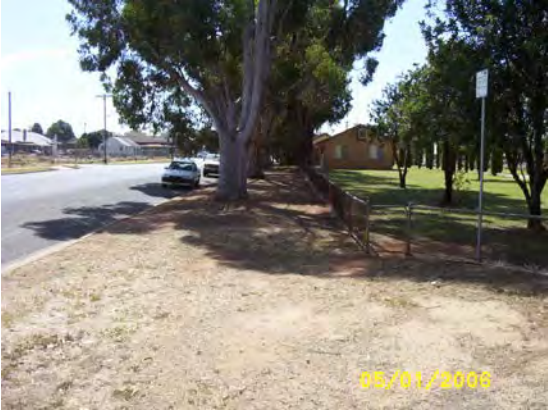
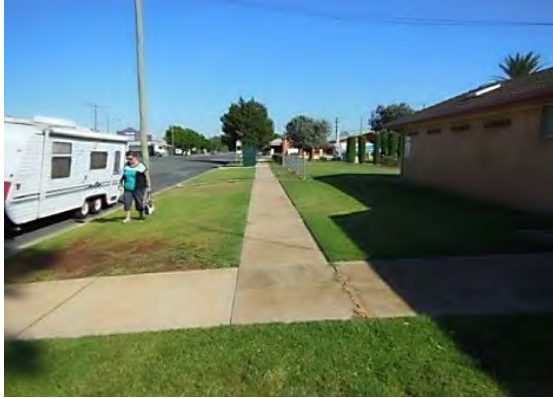
| Work ID | Routes | Photo ID | Key Inspection issues |
|---|--|---|---|
| F23 | <p>Dennison St from Tuppal Street heading south.</p> | 43 | <p>In the longer term, a path on the north side of Wollamai adjacent to Memorial Park and toilet facilities, would no doubt receive regular use.</p> <p>New path to toilets and new bus stop from Murray Street</p> |

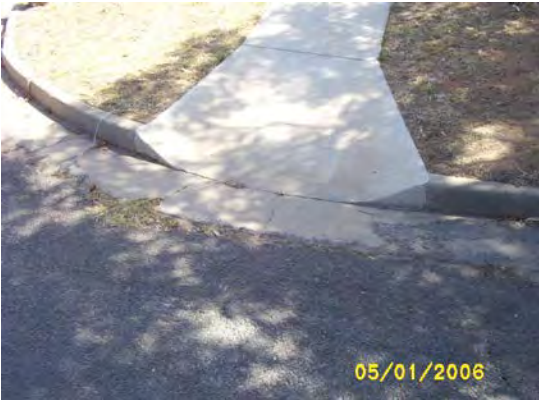
| Work ID | Routes | Photo ID | Key Inspection issues |
|---|--|---|---|
| | | 44 | <p>Kerb ramp at Tuppal and Denison Sts, north west corner.</p> |

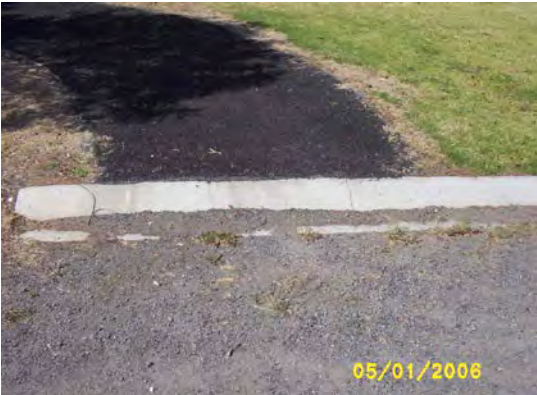
| Work ID | Routes | Photo ID | Key Inspection issues |
|---|--|---|---|
| | | 45 | <p>Entrance to Finley Lake Trail at Denison and Tuppal Sts.</p> |

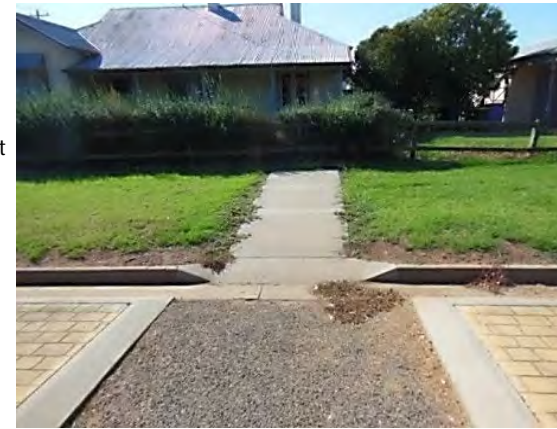
Part of blister crossing near church, but no path other side.

Consider intallation of a kerb ramp east side of Denison, and constriction of a short path link back to Tuppal St.

Installed

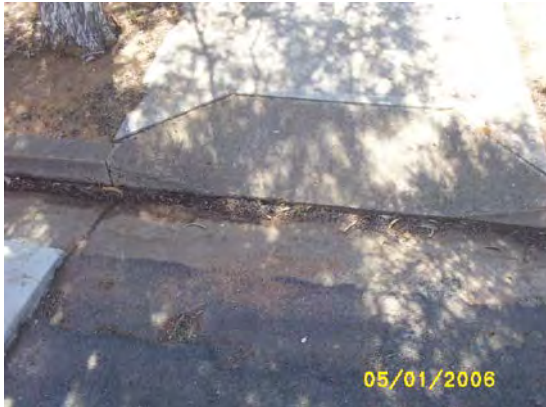
47

Deep lip at channel invert, blister crossing above.

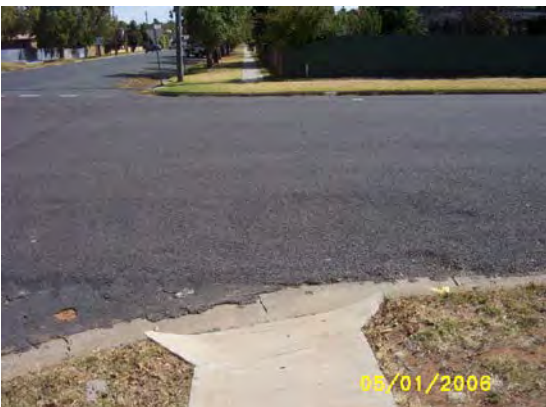
48

No ramp or path link opposite Scots Church at Wollamai and Denison Sts.

Installed

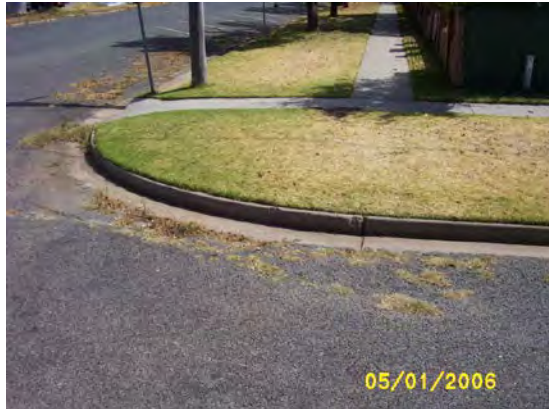
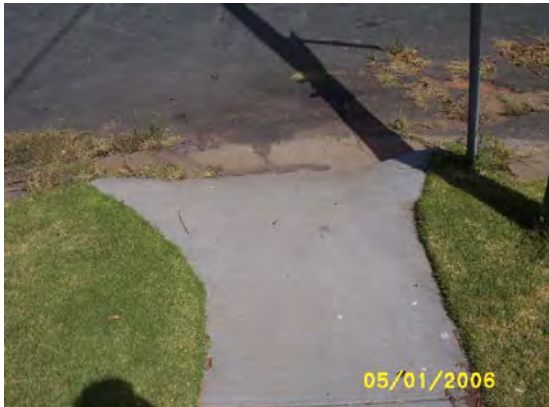
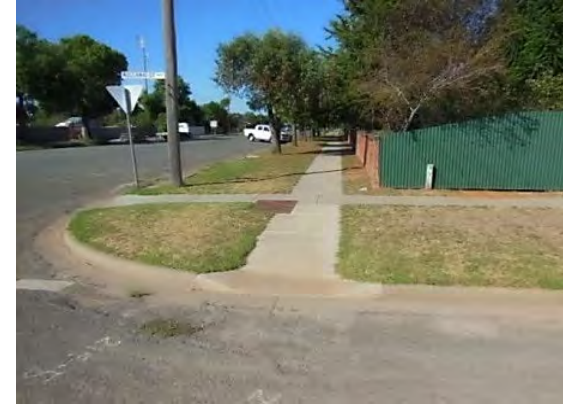
| Work ID | Routes | Photo ID | Key Inspection issues | |
|---|---|---|---|--|
| F27 | | 49 | Wollamai and Denison Sts, south west corner. Path link and new ramp needed. See above photo. | |
| | | 50 | Wollamai and Denison Sts, south west corner. | |

Installed

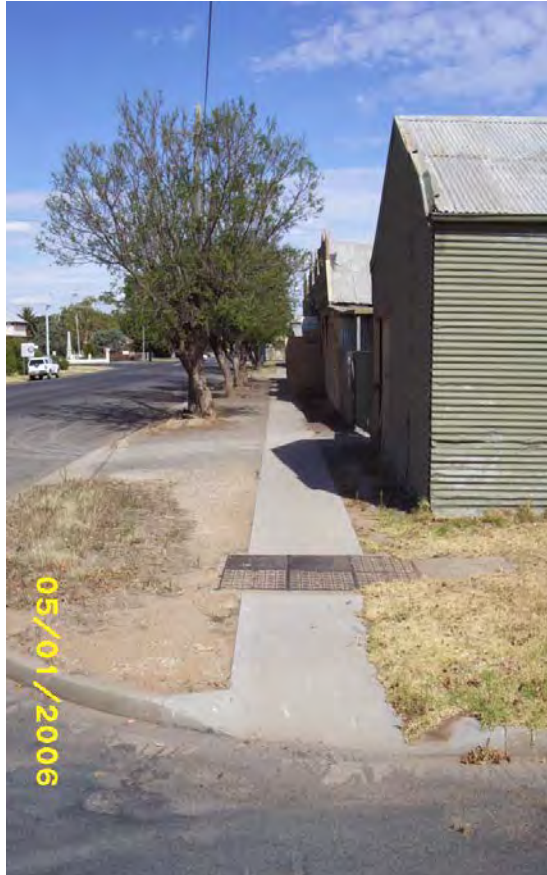
51

Wollamai and Denison Sts, south east corner.

New Path

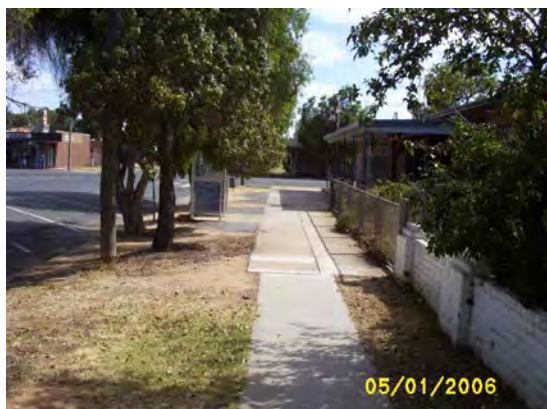
52

Denison St looking south to Warmatta St.
This path does not continue to include a kerb ramp at Warmatta St

Revamped

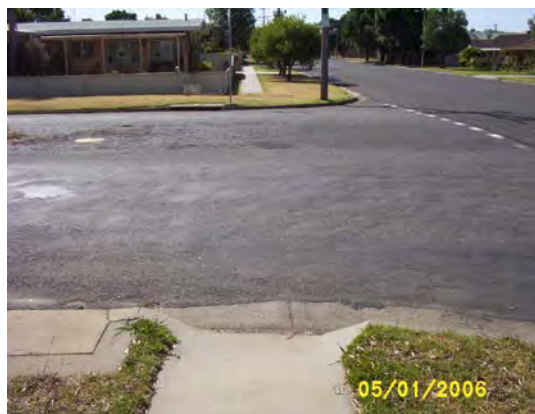
65

Why no path link and kerb ramp, west side of Denison St at Headford St?

Ramp Installed

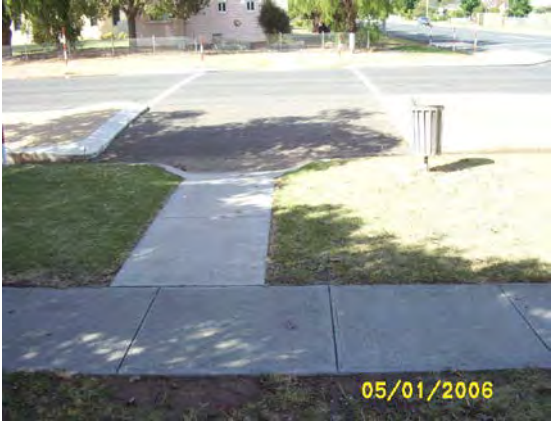
| Work ID | Routes | Photo ID | Key Inspection issues |
|---|---|---|--|
| | | | Blister crossing and ramp. At Warmatta and Coree Sts. |

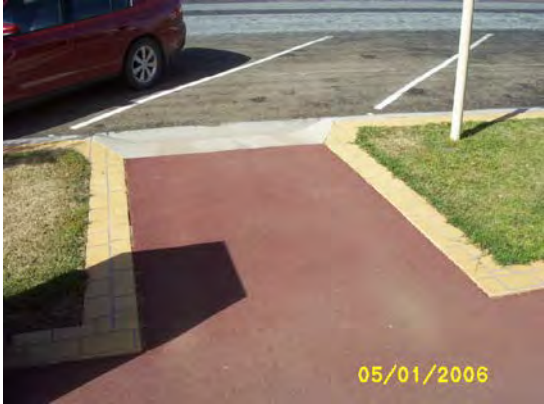
| Work ID | Routes | Photo ID | Key Inspection issues |
|---|---|---|---|
| | | 75 | Typical mid block kerb ramp, north side of Warmatta St between Murray St and Denison St. |

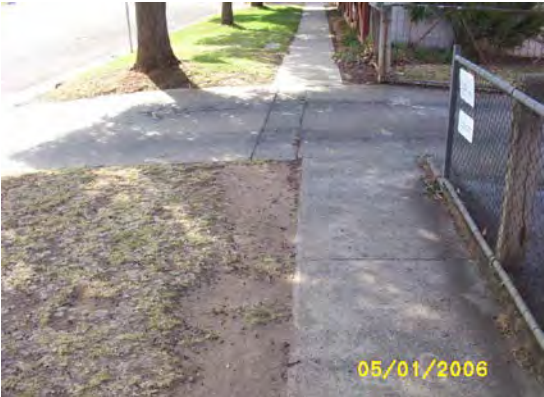
| Work ID | Routes | Photo ID | Key Inspection issues |
|---|---|---|---|
| F21 | | 76 | Note change of path alignment past Post Office - looks like path could be wider at post Office end. |

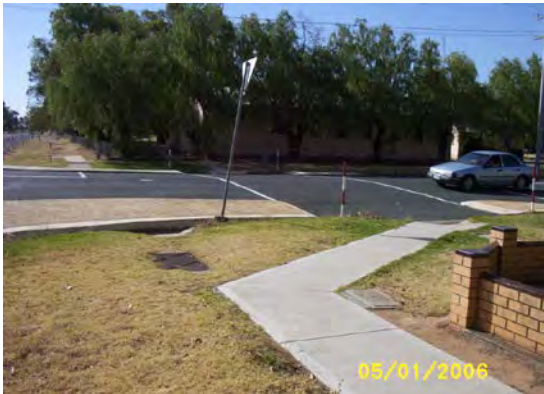
| Work ID | Routes | Photo ID | Key Inspection issues |
|---|---|---|---|
| | | 77 | Detail of crossing, north east corner of Warmatta and Coree Sts. |

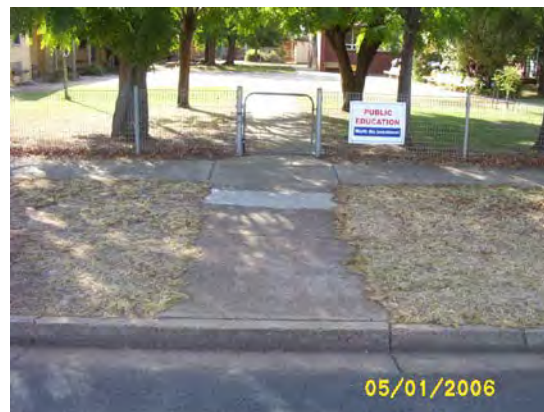
78

Ramp at north east corner, Warmatta and Coree Sts.

Repaired

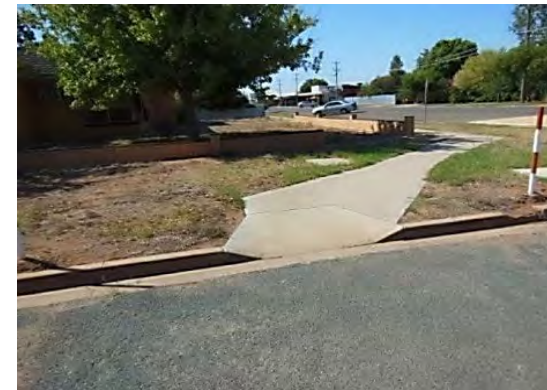
79

Ramp at north west corner, Warmatta and Coree Sts.

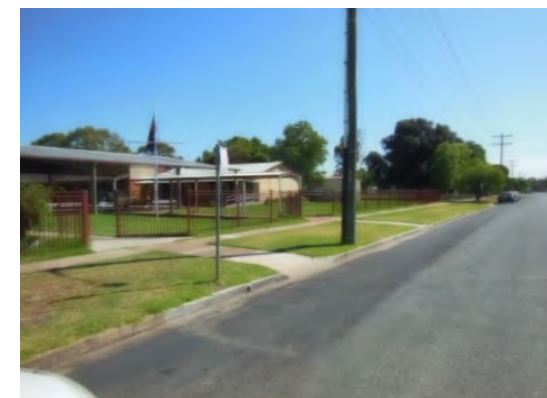
80

No kerb ramp at paths to school gates.

Installed

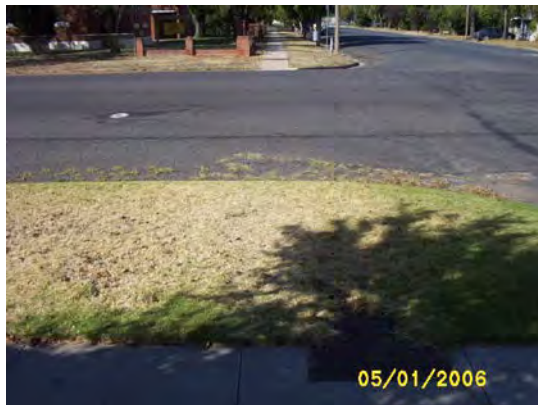
84

No kerb ramp and path link from Wollamai St to Scots Curch at Denison St, west side.

Repaired

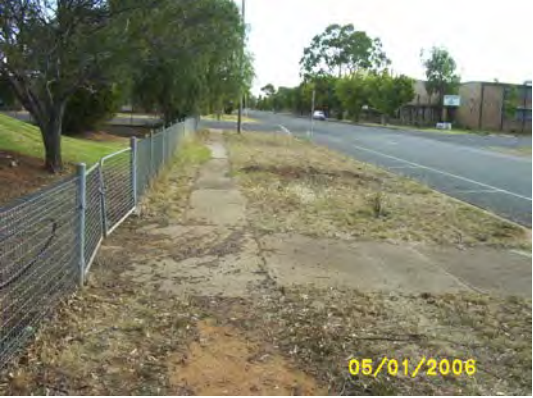
| Work ID | Routes | Photo ID | Key Inspection issues |
|---|---|---|--|
| F39 | | 87 | <p>Short section of Path east side of Tocumwal St just north of Warmatta St. This path should be continued back to Wollamai and Tuppal Sts.</p> |

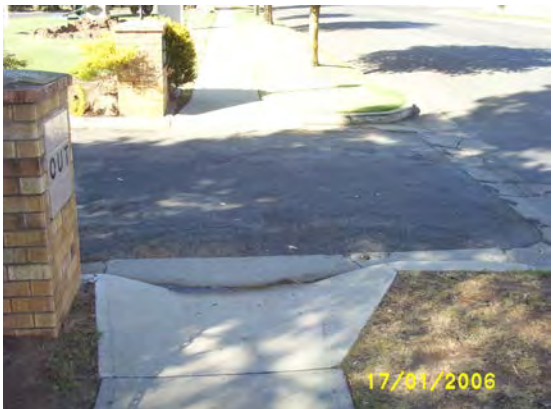
95

Southern car park access, RSL.

Off-road access for mopeds from Hospital to town will require path works and a crossing near Headford and Tocumwal Streets.

Installed

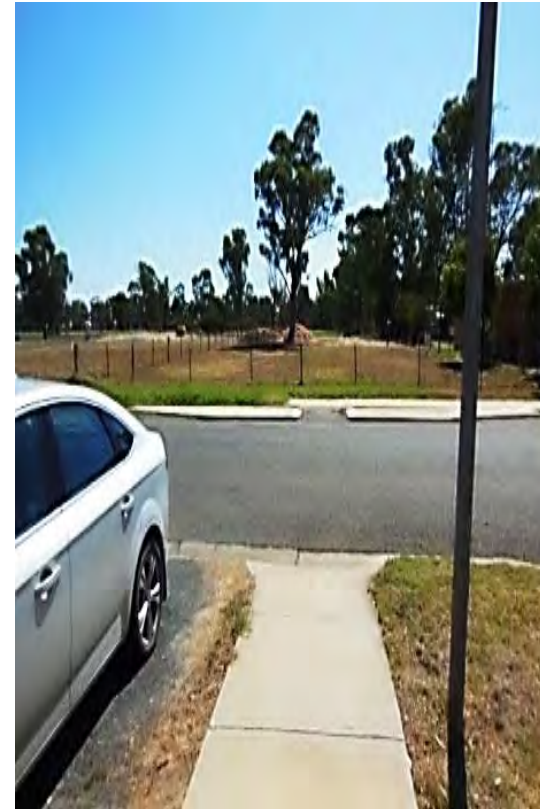
98

Crossing point is oriented directly at vehicle access to Hospital. Relocate crossing. Provide full blister crossing.

Moved and blistered

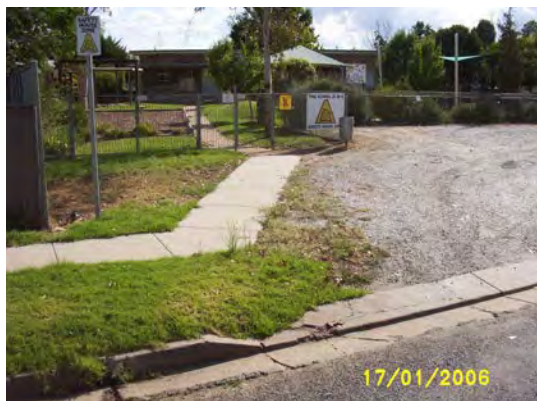
99

A path on the south side of Dawe Ave gives access to a pre-school centre. Consider protective bollards or short fence between path and car access.

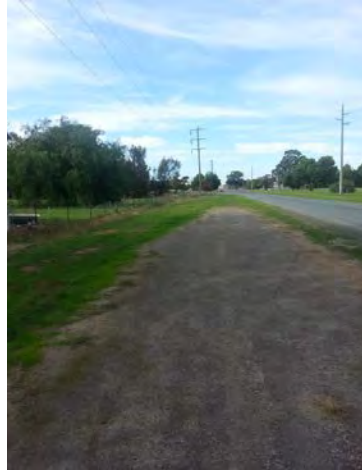
Walking/Cycling path in Tongs Street needs connection to Murray Street
