BERRIGAN SHIRE COUNCIL

BERRIGAN PEDESTRIAN ACCESS AND MOBILITY PLAN

Des Gunn Landscape Design/Review Berrigan Shire Council

Adopted 16th July, 2014

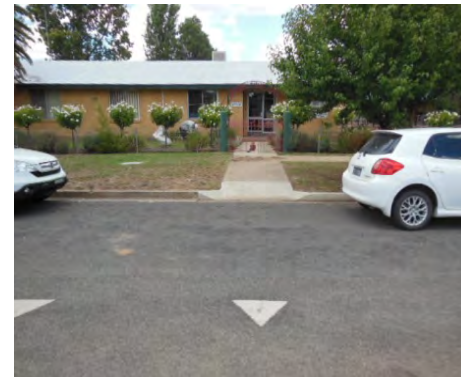
No ramp at school entry, Momalong St

Ramp in place

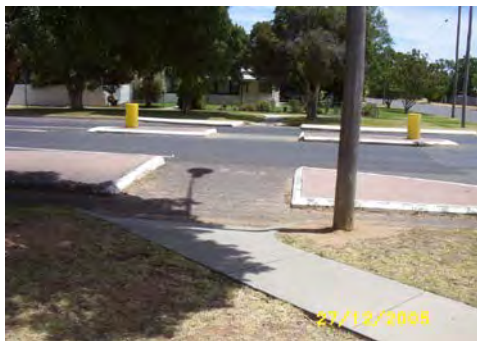
6

Blister crossing on Jerilderie St at
Momalong St.

The ramp at Jerilderie St east side is steeper than the recommended 1:8 ramp grade.

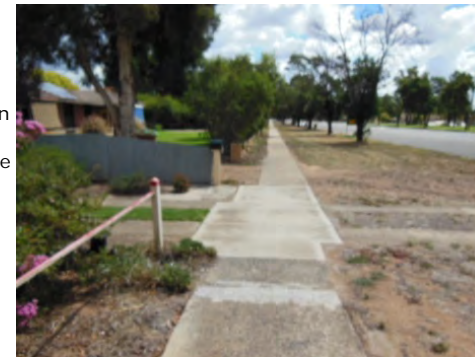
Path on west side of Jerilderie between Momalong St and Memorial Place. Alignment changes and rough concrete at driveway, No 129.

Retification has been taken

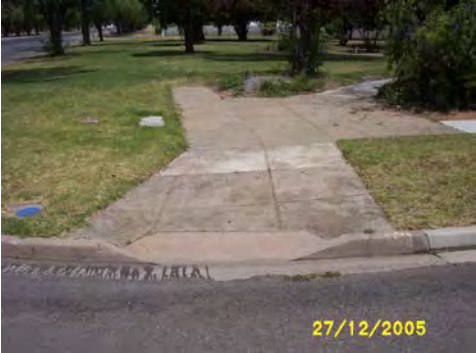
Kerb Ramp at Jerilderie St and Memorial place north corner. Lip at channel excessive.

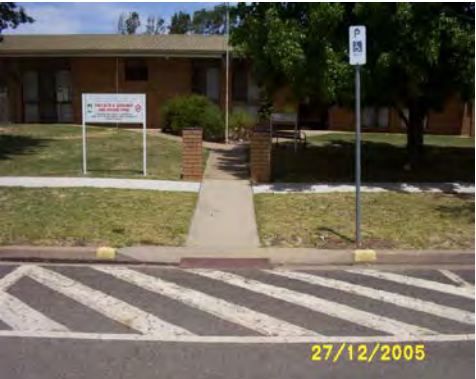
Kerb Ramp at Jerilderie St and Memorial place south corner.

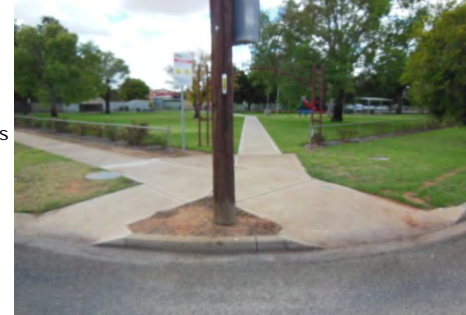
18

This whole corner at Cobram and Davis Sts needs a makeover, including pavement and kerb ramps.

New ramp to kerb

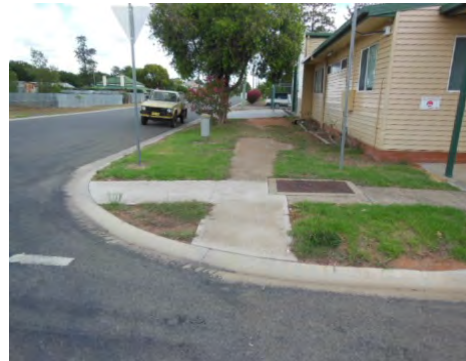
19

Kerb ramp needed, north west corner of Cobram and Budd Sts to link across to Apex Park.

New ramps

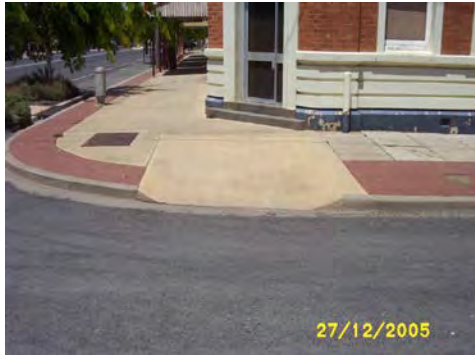
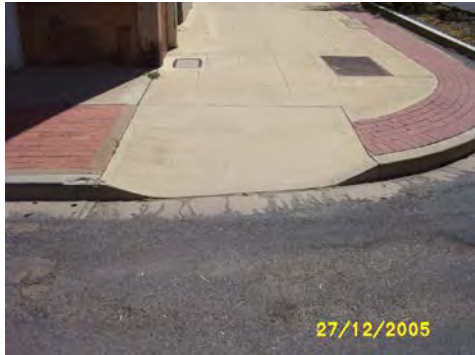
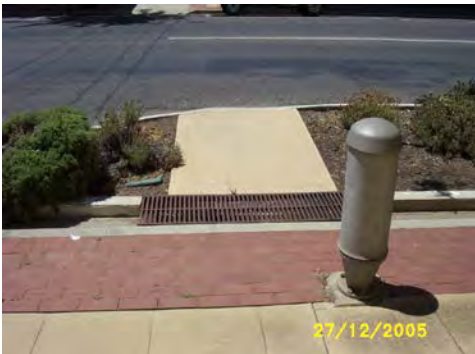
Work ID	Routes	Photo ID	Key Inspection issues
		21	
			Kerb ramp at Cobram and Chanter Sts, east side.
		22	
			Kerb ramp at Cobram and Chanter Sts, west side.
		23	
			This ramp doesn't appear to be going anywhere on the other side. Discontinue crossing this location.

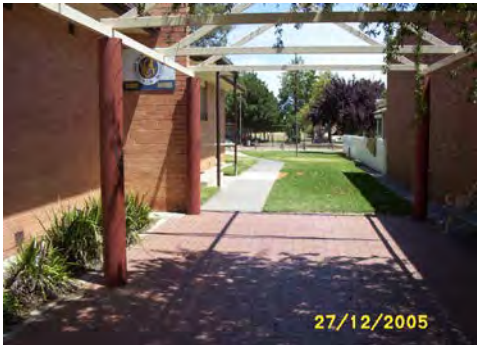
24

Above crossing viewed from other side.

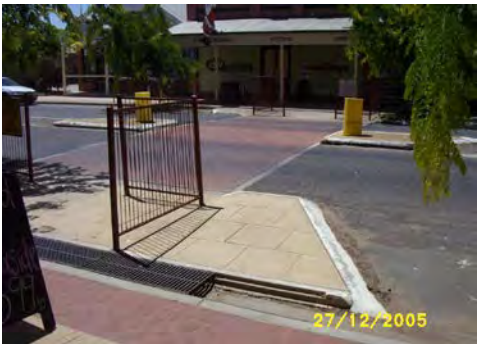
25

Path link from Chanter St to parking and Apex Park.

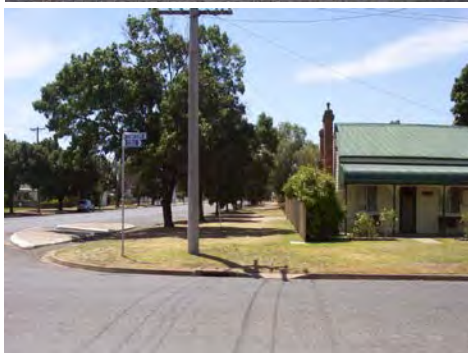
Be9

Where kerb and path are not aligned, a wider ramp apron would be useful, allowing the path a wider profile adjacent to the ramp.

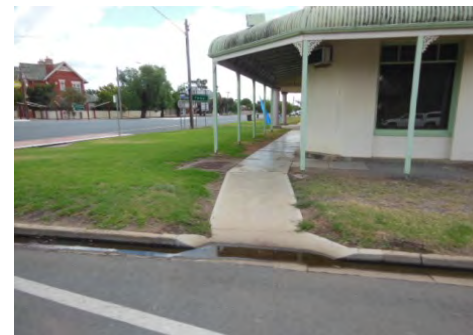
32

Ramp in Carter St to Belmont Buildings. Very steep section adjacent to channel. Path overgrown.

Re-worked - refer to foothpath inspections MAY 2013

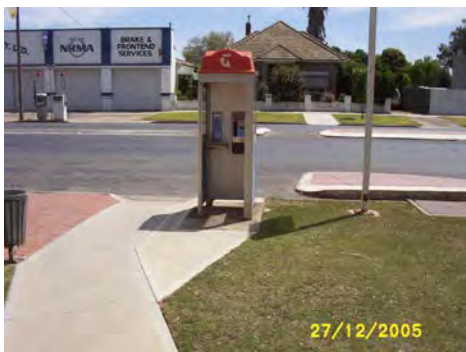
34

Kerb ramp to Post Office, Carter St

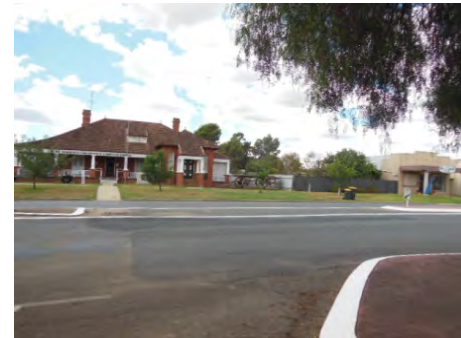
40

Consider upgrade of crossing at RSL.
Provide raised refuge island both sides of walkway. Consider hand rails.

Line marking

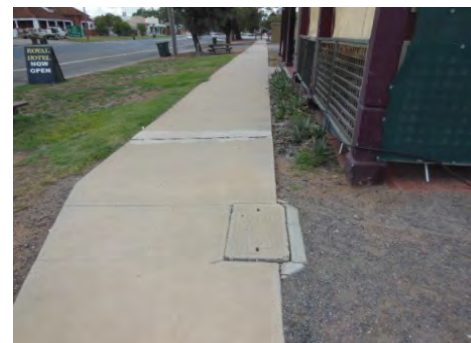
47

Telstra Pit Cover near Hotel is a trip
hazard.

Partially rectified

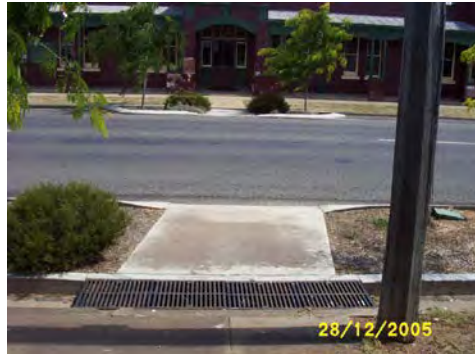
48

Informal crossing at Federal Hotel in
Chanter St.

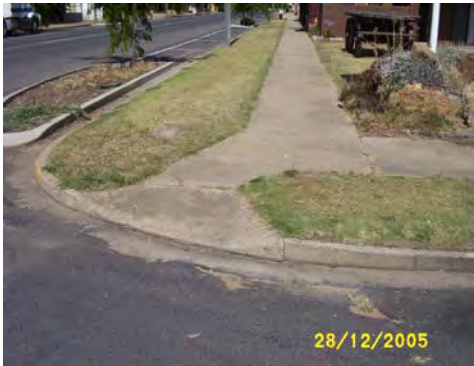
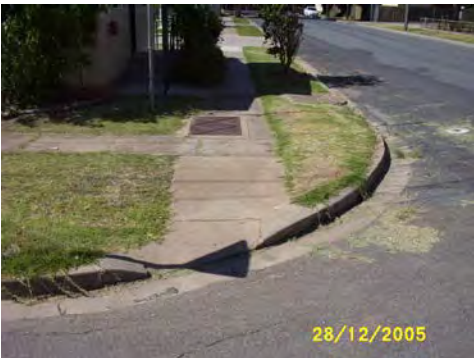
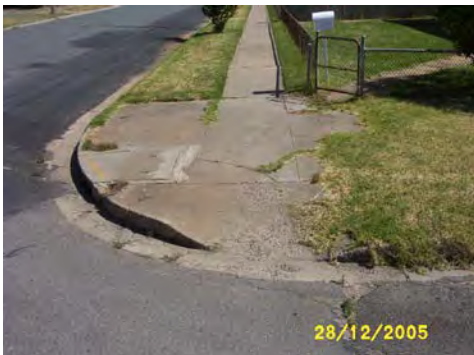
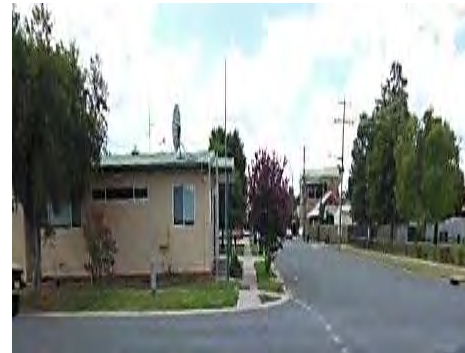
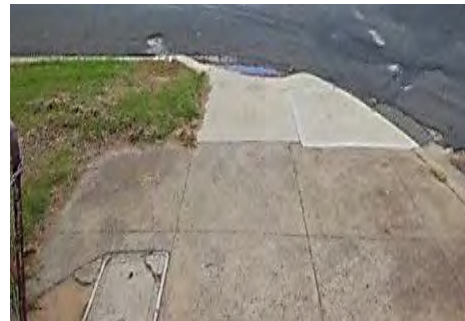
Work ID	Routes	Photo ID	Key Inspection issues	
		53	<p>This ramp treatment at Chanter and Mitchell Sts would benefit from reworking to the same width and line as the approaching path.</p>	Replaced, no change to alignments
Be6		54	<p>Ramps at Cobram and Budd Sts are steep, narrow, broken in places and require reworking. See also photo below.</p>	Ramps replaced
Be6		55	<p>See photo above. Need new ramp across to Davis St also.</p>	Ramps replaced

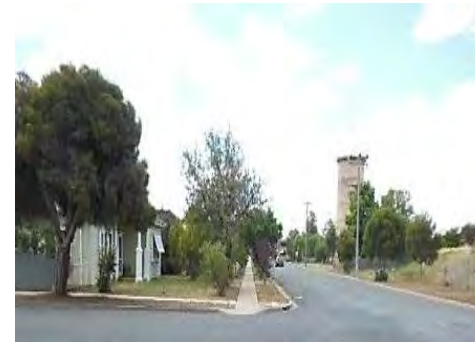
56

Ramp at Cobram and Stewart Sts,
north west corner.

Ramps replaced

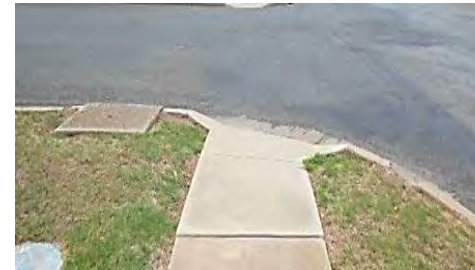
Ramp at Cobram and Stewart Sts,
south west corner.

Excessive lip, broken concrete around
ramp. Maintenance upgrade required.

Ramps replaced

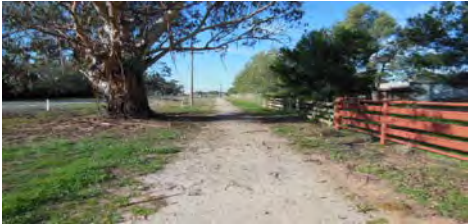
This area is approximately 100m's from the entry to McNaught's towards the town centre, it is mainly a few weeds together with fallen bark and twigs

Risk Rating LOW

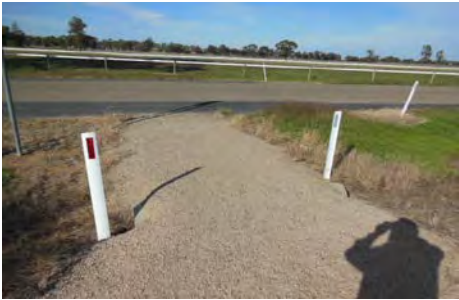
This is at the path entry from Racecourse Rd.
The guide posts should be in line with each end of the culvert pipe to detail the actual width

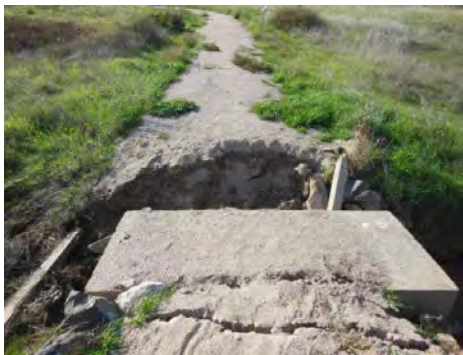
This photo shows the area between the two ponds.
This problem has been forwarded to the overseer's for immediate attention

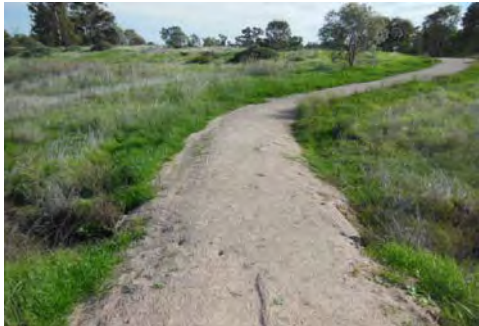
Approximately 90m's from the ponds.
Needs to be made identifiable with the use of guide posts

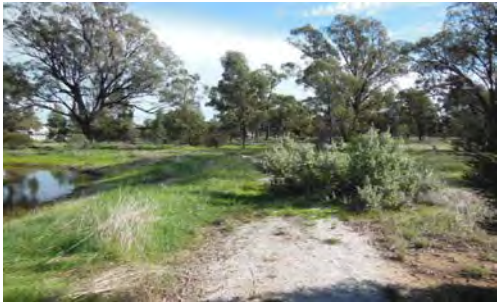
This section is next to the pond and the bush shown is an obstruction

MEDIUM

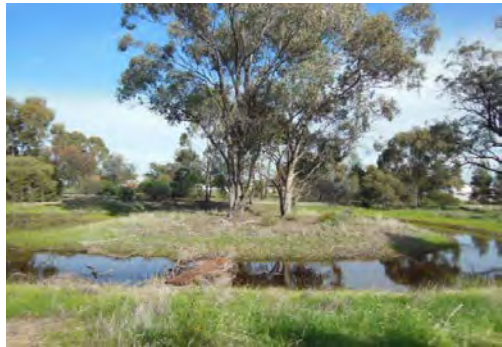
Risk Rating

MEDIUM
